# JOINT INVESTIGATION REPORT

INCIDENT NO: 2142698 JIV report S/N: 0039

1. Spill incident Number: 2142698      2. Type of incident\*: OIL SPILL  
 3. Name of Location: 14<sup>th</sup> OKORDIA - RUMUEKPE PIPELINE  
 4. Name of nearest community: IMOGU (RUMUEKPE)      5. State: RIVERS      6. LGA: EMOHUA  
 7. Type of Production facility/Installation: OIL PIPELINE  
 8. Asset owner/District: THE SHELL PETROLEUM DEVELOPMENT COMPANY OF NIGERIA LIMITED (SPDC) / PIPELINE

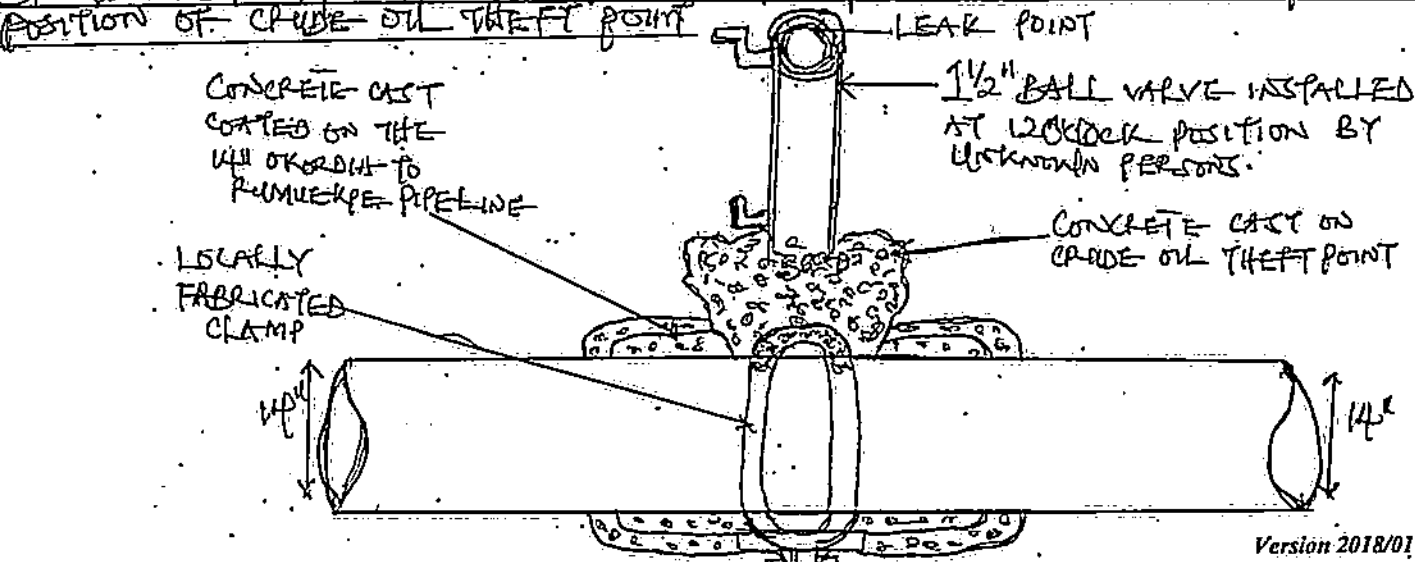
Additional observations around the spill point: THE JOINT INVESTIGATION TEAM OBSERVED A 1 1/2" VALVE INSTALLED AT 12 O'CLOCK POSITION WITHIN A CONCRETE CAST ON CRUDE OIL THEFT POINT.

| <input checked="" type="checkbox"/> Failed Weld-on illegal hot tap valve. | <input type="checkbox"/> Failed Clamp | <input type="checkbox"/> Missing Pipeline/Flowline |
| <input checked="" type="checkbox"/> Crude oil theft (illegal bunkering) point | <input type="checkbox"/> Saver-pit over flow | <input type="checkbox"/> Third party tampering with Clamp |

SECTION OF 14" OKORDIA - RUMUEKPE PIPELINE AT RUMUEKPE SHOWING POSITION OF CRACK ON THE FT POINT

RECOVERY AND REPAIR ACTIVITIES ARE ONGOING

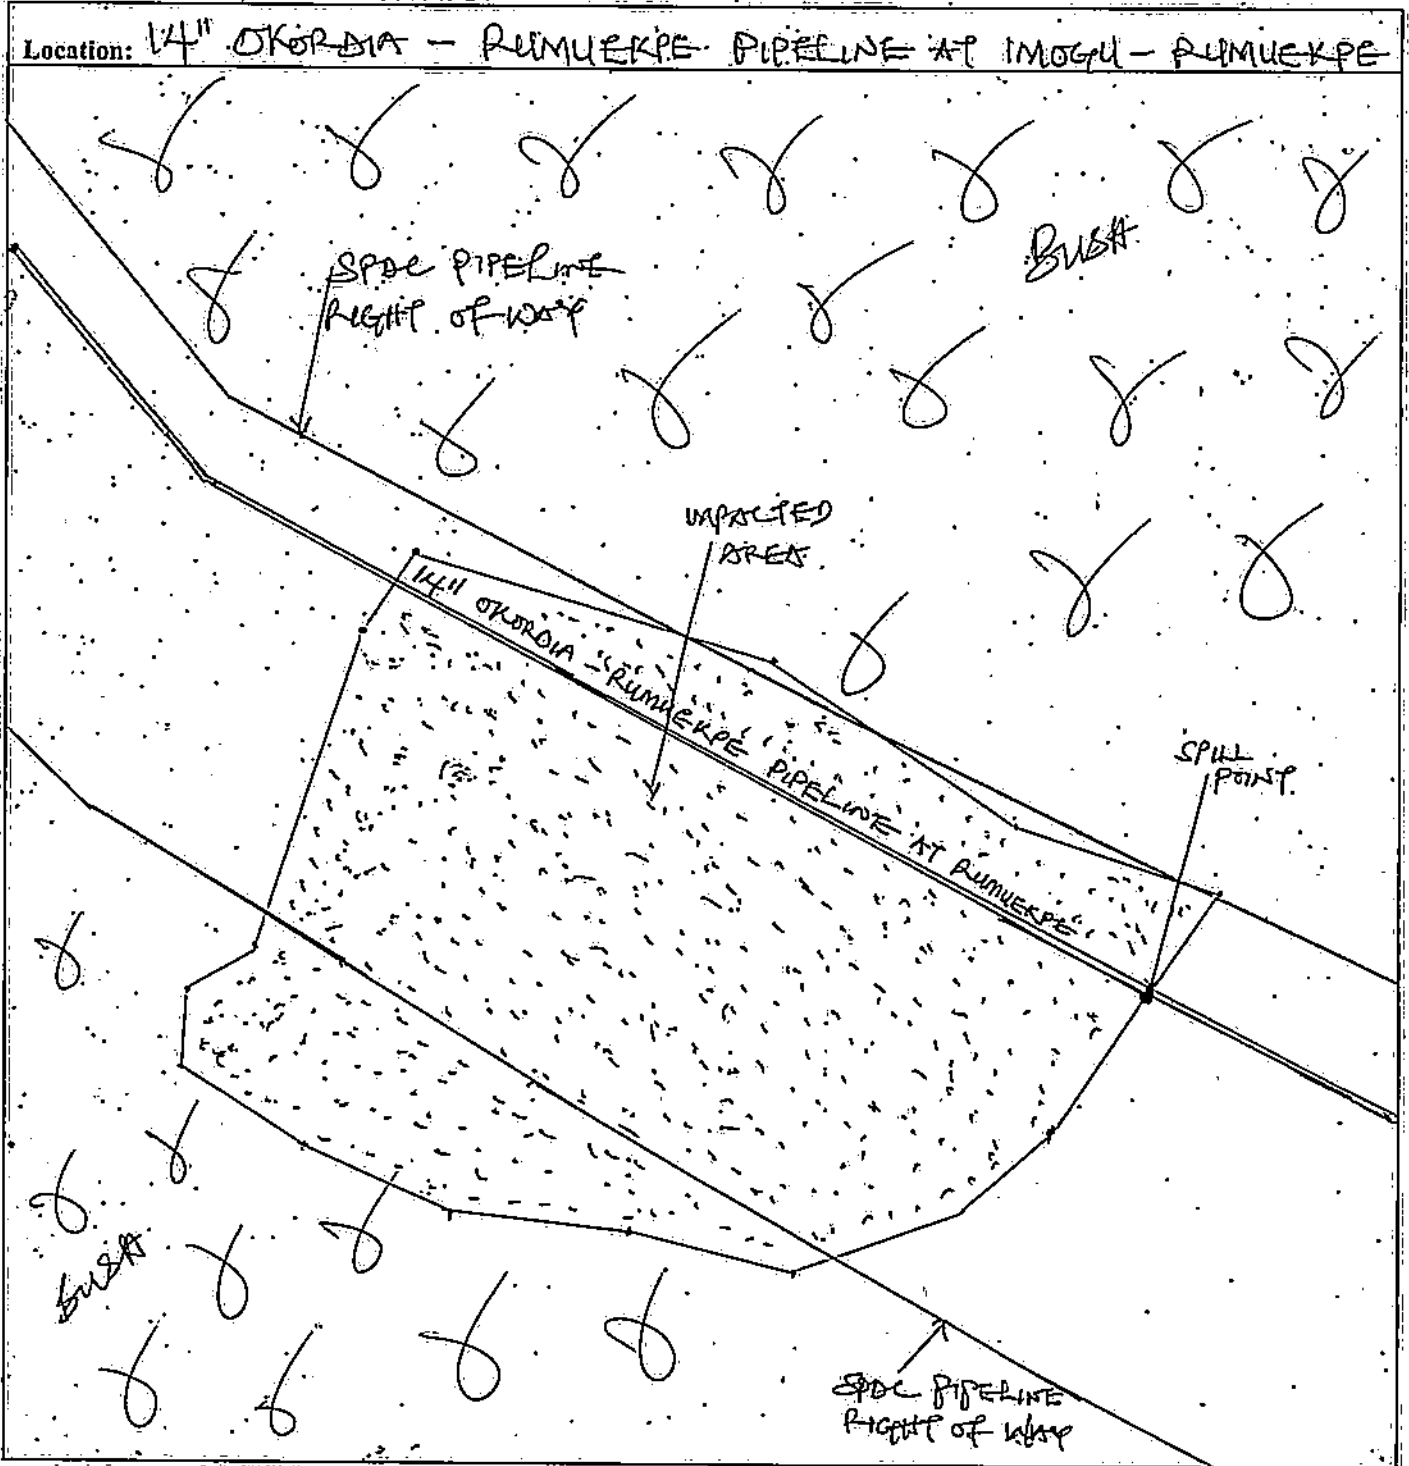
f. Appendix 1: Overview sketch of the site

- Total calculated area of impact 0.4834ha
- Impact within R.O.W YES
- Impact outside R.O.W YES
