JOINT INVESTIGATION REPORT

INCIDENT NO: 2142865 JIV report S/N: 0037

- 1. Spill incident Number: 2142865 2. Type of incident*: OIL SPILL
- 3. Name of Location 20" KOLD CREEK - RUMUOKPE PIPELINE
- 4. Name of nearest community (IMOGU) 5. State: RYNERS 6. LGA SMOKUA
- 7. Type of Production facility/Installation OIL PIPELINE
- 8. Asset owner/District THE SHELL PETROLEUM DEVELOPMENT COMPANY OF NIGERIA LIMITED (SPDC) / PIPELINE

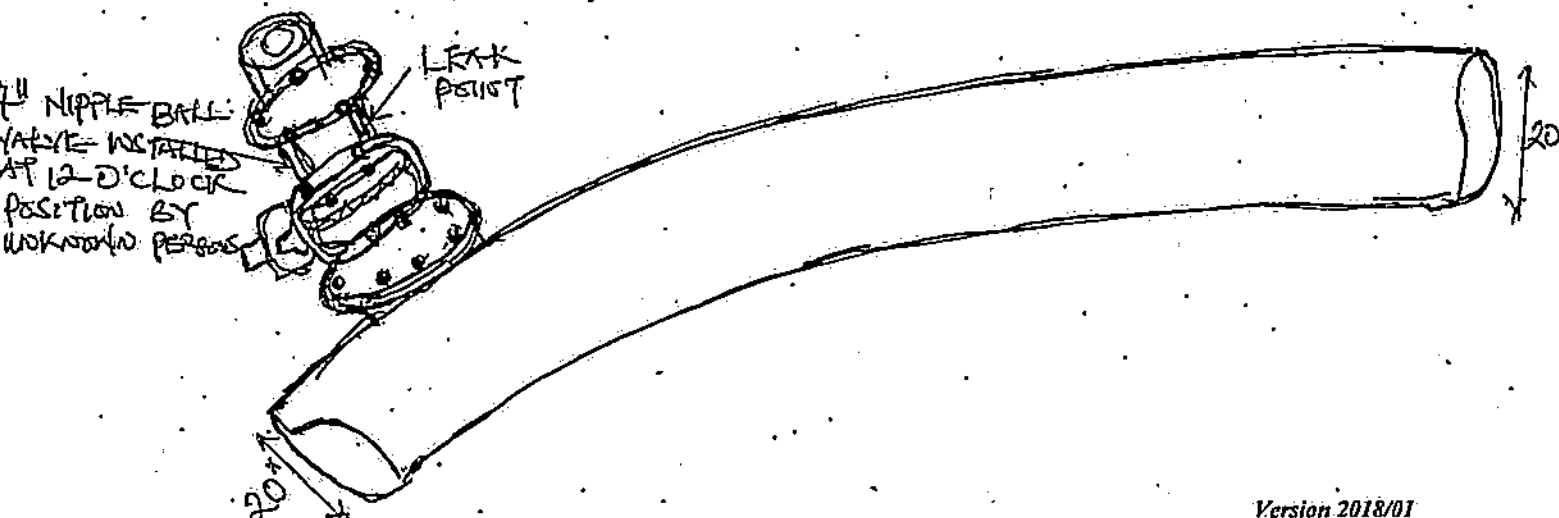
Additional observations around the spill point: THE JOINT INVESTIGATION TEAM OBSERVED A 4" NIPPLE BALL VALVE INSTALLED AT 12 O'CLOCK POSITION BY UNKNOWN PERSONS.

SECTION OF 20" HOLLOWER - RUMUKEPE PIPELINE AT RUMUKEPE SPONGING POSITION OF CRUDE OIL TREST POINT.
