JOINT INVESTIGATION REPORT

INCIDENT NO: 2142049 JIV report S/N: 0031

1. Spill incident Number: 2142049 2. Type of incident* OIL SPILL
3. Name of Location 12" IMO RIVER - OGALE PIPELINE
4. Name of nearest community ODAGWA 5. State: RIVERS 6. LGA ETCHE
7. Type of Production facility/Installation OIL PIPELINE
8. Asset owner/District THE SHELL PETROLEUM DEVELOPMENT COMPANY OF NIGERIA LTD (SPDC) / PIPELINE

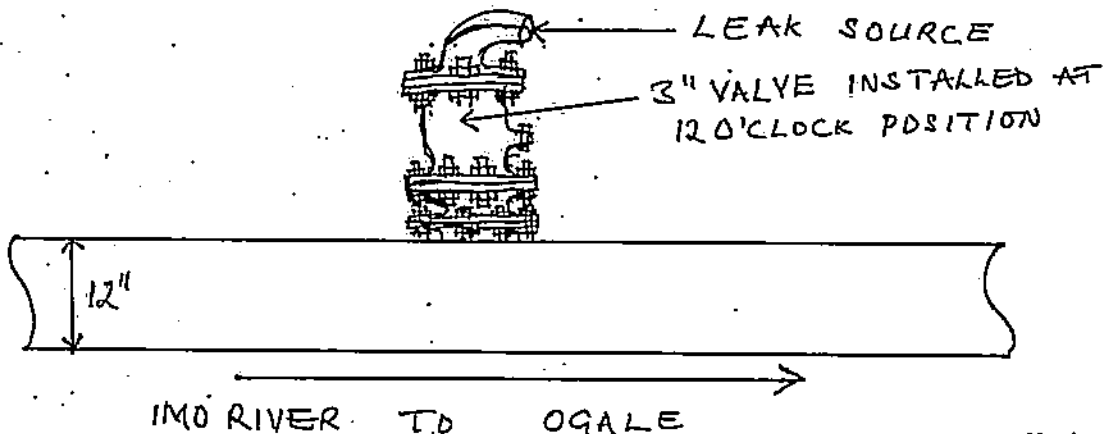
Additional observations around the spill point: THE JIT OBSERVED 3" VALVE INSTALLED AT 12 O'CLOCK POSITION BY UNKNOWN PERSONS.

| <input checked="" type="checkbox"/> Crude oil theft (illegal bunkering) point | <input type="checkbox"/> Saver-pit over flow | <input type="checkbox"/> Third party tampering with Clamp |

E. GRAPHIC DESCRIPTION OF LEAK POINT (while detailed report of the leak point should be contained in the leak report, overview sketch of the site should be added as an appendix 1) A SECTION OF 12" IMO RIVER - OGALE PIPELINE AT ODAGWA SHOWING 3" VALVE CRUDE THEFT POINT INSTALLED AT 12 O'CLOCK POSITION BY UNKNOWN PERSONS.

LEAK REPAIR
