JOINT INVESTIGATION REPORT

INCIDENT NO: 2152522 JIV report S/N: 0081

1. Spill incident Number: 2152522 2. Type of incident*: OIL SPILL
3. Name of Location 14" OKORDIA - Rumuekpe Pipeline
4. Name of nearest community IHUONDO 5. State: RIVERS 6. LGA ABADA EAST
7. Type of Production facility/Installation OIL PIPELINE
8. Asset owner/District THE SHELL PETROLEUM DEVELOPMENT COMPANY OF NIGERIA LIMITED PIPELINE

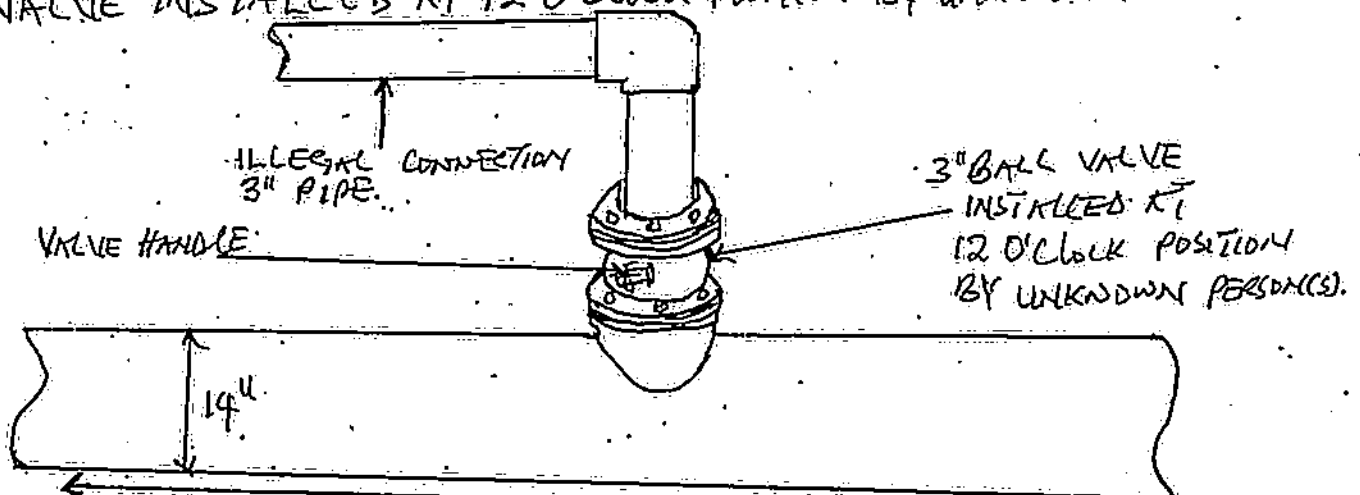
Additional observations around the spill point: THE JOINT INVESTIGATION TEAM OBSERVED 3" BALL VALVE INSTALLED AT 12 O'CLOCK POSITION BY UNKNOWN PERSONS.

| <input checked="" type="checkbox"/> Crude oil theft (illegal bunkering) point | <input type="checkbox"/> Saver-pit over flow | <input type="checkbox"/> Third party tampering with Clamp |

- ☒ Third party interference (Sabotage ☐; crude theft ☒; Line theft ☐; Accidental 3rd party damage ☐
☐ Operational ☐ Mystery spills ☐ Others (specify) _____

E. GRAPHIC DESCRIPTION OF LEAK POINT (while detailed report of the leak point should be contained in the leak report, overview sketch of the site should be added as an appendix 1) A SECTION OF 14" OKORDIA - RUMUEKPE PIPELINE AT IHUDW6 SHOWING 3" BALL VALVE INSTALLED AT 12 O'CLOCK POSITION BY UNKNOWN PERSON(S).

yes to item 14, give brief description:
RECOVERY OF CRUDE OIL AND REPAIR BY CLAMPING
ON GOING.

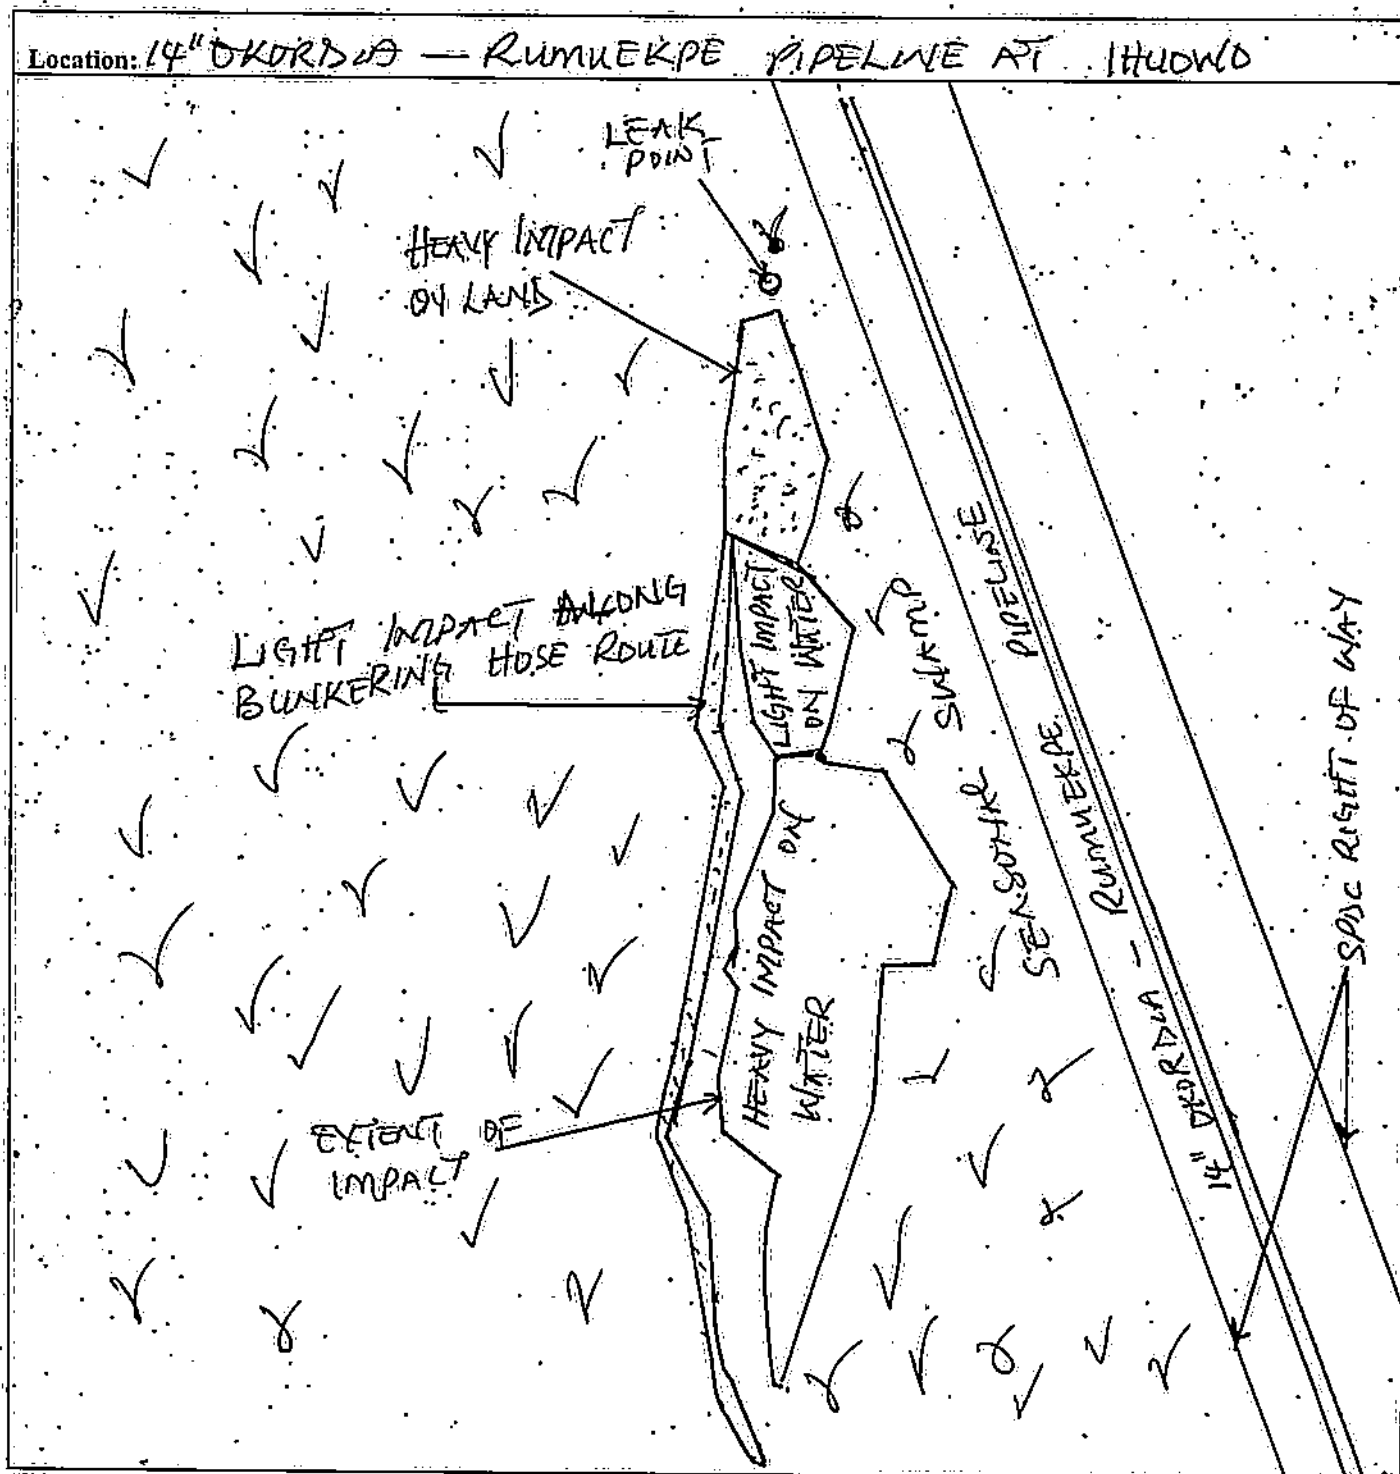
f. Appendix 1: Overview sketch of the site

- Total calculated area of impact 0.699 Hectfs
- Impact within R.O.W NIL
- Impact outside R.O.W 0.699 Hectfs
