# JOINT INVESTIGATION REPORT

INCIDENT NO: 2154148 JIV report S/N: 0082

1. Spill incident Number: 2154148 2. Type of incident\*: OIL SPILL  
3. Name of Location: 8" ISMIRI - IMB GATE: PIPELINE  
4. Name of nearest community: UMUELECHI 5. State: ABIA 6. LGA: UKWA WEST  
7. Type of Production facility/Installation: OIL PIPELINE  
8. Asset owner/District: THE SHELL PETROLEUM DEVELOPMENT COMPANY OF NIGERIA LIMITED PIPELINE

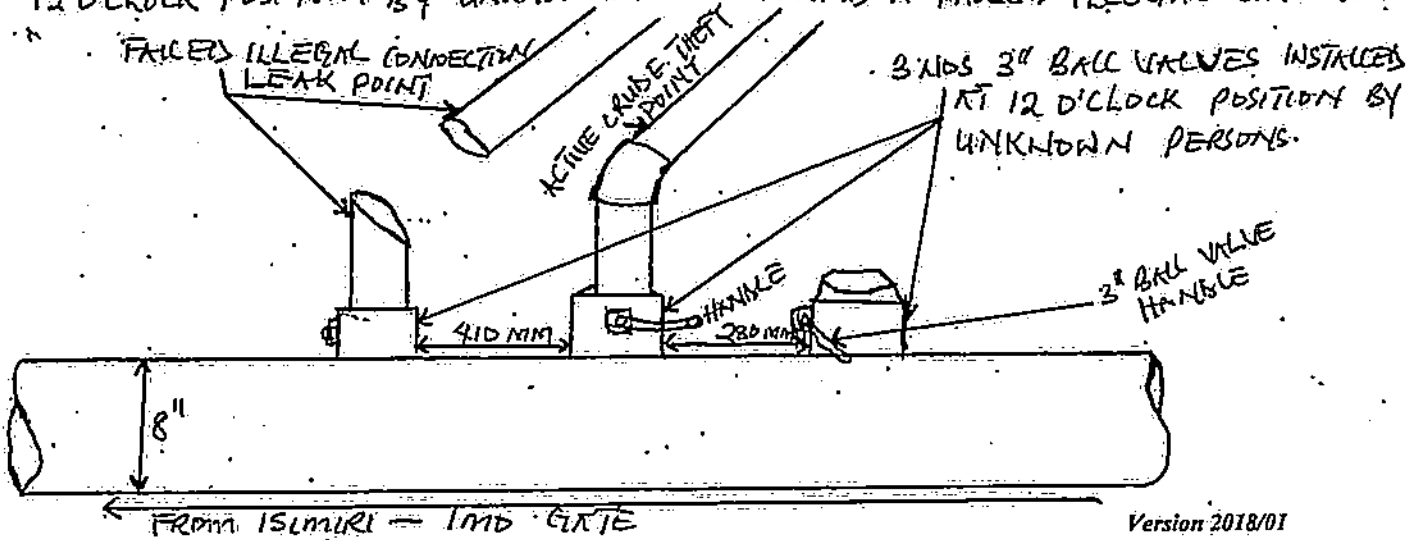
**E. GRAPHIC DESCRIPTION OF LEAK POINT** (while detailed report of the leak point should be contained in the leak report, overview sketch of the site should be added as an appendix 1) A SECTION OF 8" ISUMI - IMB GATE PIPELINE AT UMUELECHI STATION 3 NOS 3" BALL VALVES INSTALLED AT 12 O'CLOCK POSITION BY UNKNOWN PERSON(S) AND A FAILED ILLEGAL CONNECTION.

CRUDE OIL RECOVERY AND PIPELINE REPAIR BY  
 CLAMPING ARE ONGOING.
