JOINT INVESTIGATION REPORT

INCIDENT NO: 2133476 JIV report S/N:0033

1. Spill incident Number: 2133476 2. Type of incident* OIL SPILL
3. Name of Location 14" OKORDIA - RUMUEKPE PIPELINE
4. Name of nearest community IKARAMA 5. State: BAYELSA 6. LGA YENAGOA
7. Type of Production facility/Installation OIL PIPELINE
8. Asset owner/District THE SHELL PETROLEUM DEVELOPMENT COMPANY OF NIGERIA LTD (SPDC) / PIPELINE

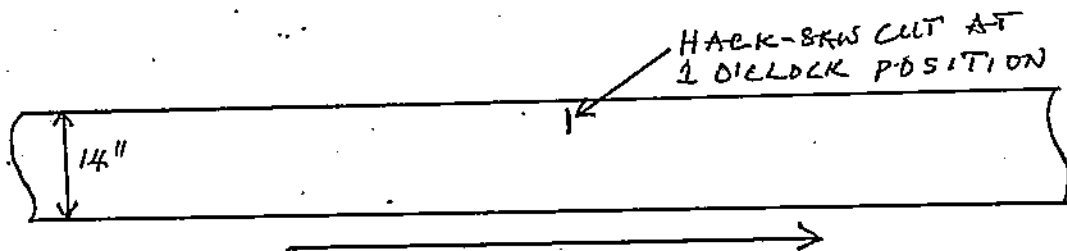
Additional observations around the spill point: THE JOINT INVESTIGATION TEAM OBSERVED A HACK SAW CUT AT 1 O'CLOCK POSITION

E. GRAPHIC DESCRIPTION OF LEAK POINT (while detailed report of the leak point should be contained in the leak report, overview sketch of the site should be added as an appendix 1) A SECTION OF 14" OKORDIA - RUMUEKPE FIRELINE AT IKARAMA SHOWING HACKSAW CUT AT 10'CLOCK POSITION DONE BY UNKNOWN PERSONS.
