JOINT INVESTIGATION REPORT

INCIDENT NO: 2145557 JIV report S/N: 0078

1. Spill incident Number: 2145557 2. Type of incident* OIL SPILL
3. Name of Location 20" KOLD CREEK - RUMUWERE PIPELINE
4. Name of nearest community ODAU 5. State: RWBS 6. LGA AGUA - ODUAL
7. Type of Production facility/Installation OIL PIPELINE
8. Asset owner/District: THE SHELL PETROLEUM DEVELOPMENT COMPANY OF NIGERIA LIMITED / PIPELINE

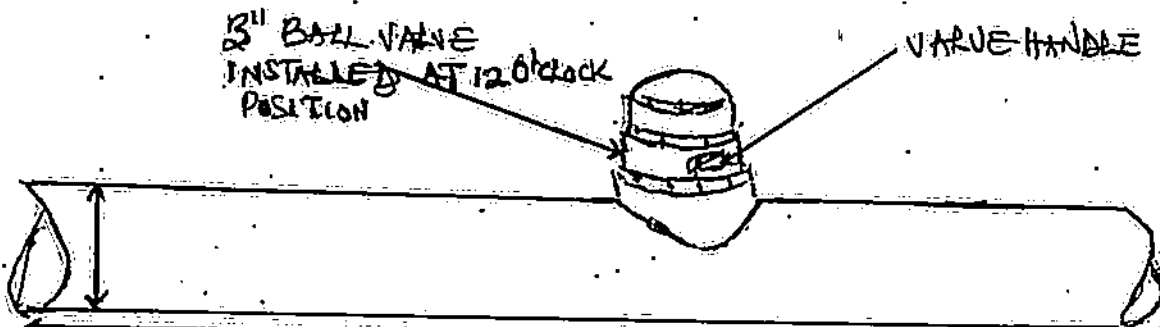
THE JOINT INVESTIGATION TEAM OBSERVED ILLEGAL CONNECTION OF A 1" GALVANIZED PIPE INDICATING CRUDE OIL THEFT.

20" KOLOCREEK - RUMUEKE PIPELINE AT ODAU WITH A 3" BALL VALVE INSTALLED AT 12 O'CLOCK POSITION BY UNKNOWN PERSONS.

RECOVERY AND REPAIR ACTIVITIES ARE ONGOING

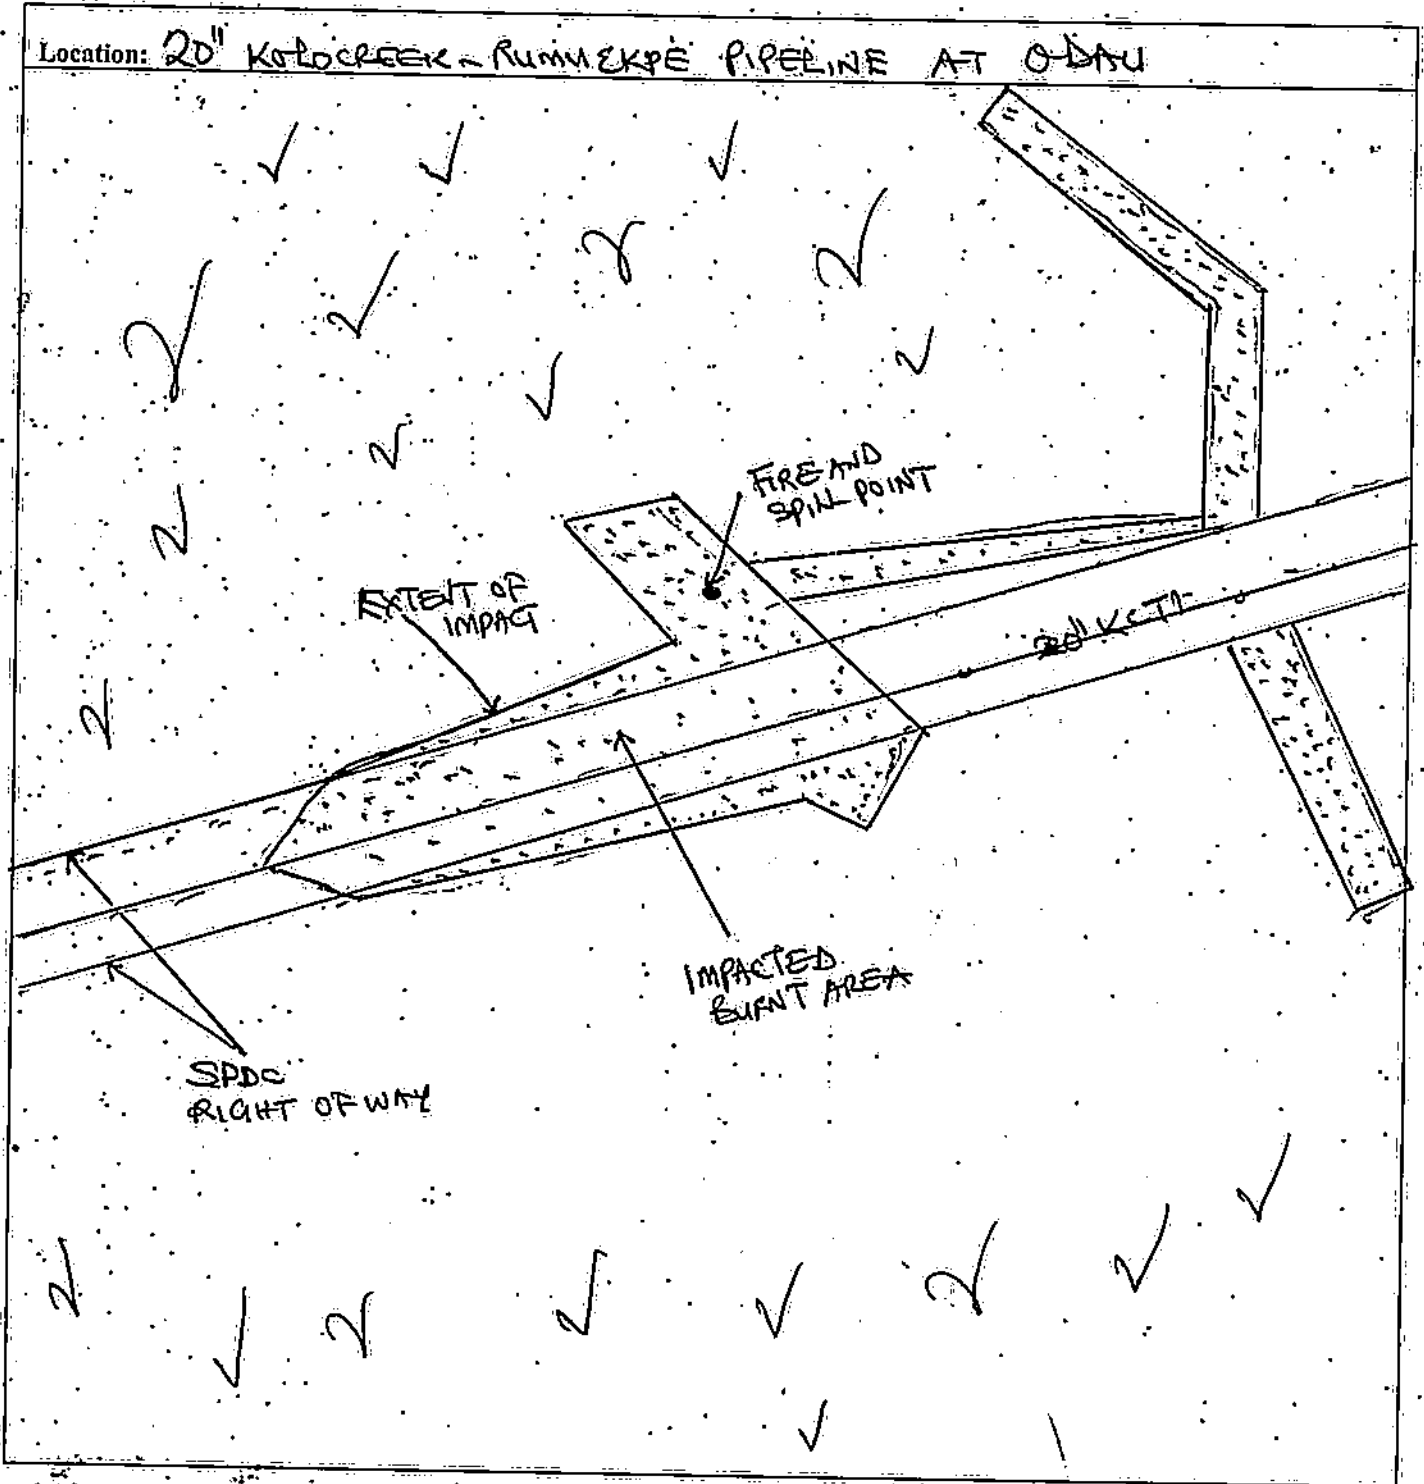
f. Appendix 1: Overview sketch of the site

- Total calculated area of impact 2.04170 Ha.
- Impact within R.O.W YES
- Impact outside R.O.W YES
