# JOINT INVESTIGATION REPORT

INCIDENT NO: 2147690 JIV report S/N: 0099

- 1. Spill incident Number: 2147690      2. Type of incident\* OIL SPILL
- 3. Name of Location 28" BOMU - BONNY TRANS NIGER PIPELINE
- 4. Name of nearest community PATRICK WATER SIDE      5. State: RIVERS      6. LGA GOKANA
- 7. Type of Production facility/Installation OIL PIPELINE
- 8. Asset owner/District THE SHELL PETROLEUM DEVELOPMENT COMPANY OF NIGERIA LIMITED / PIPELINE

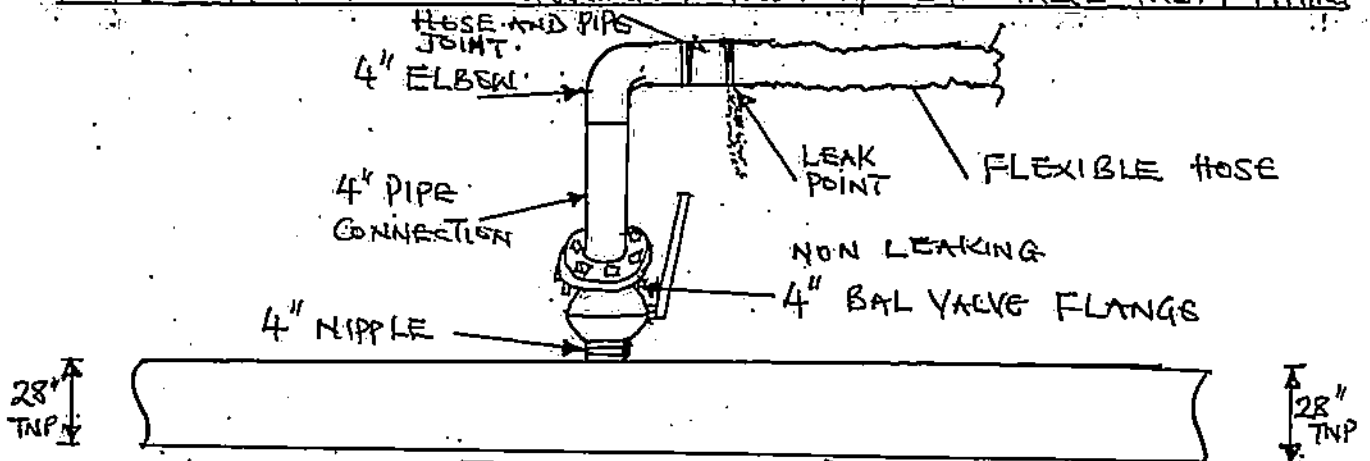
Additional observations around the spill point: THE INCIDENT WAS INITIALLY REPORTED AS SUSPECTED NON LEAKING THEFT POINT. UPON EXCAVATION, THE JOINT INVESTIGATION TEAM OBSERVED LEAKAGE AT THE POINT WHERE THE FLEXIBLE HOSE AND THE ~~PIPE~~ ILLEGAL FITTING WERE CONNECTED.

SECTIONAL VIEW OF 28" BOMU - BONNY TRANS NIGER PIPELINE AT PATRICK WATER SIDE SHOWING FAILED 4" BALL VALVE THEFT FITTING

THE JOINT INVESTIGATION TEAM OBSERVED!-  
 \* LEAK WAS FROM THE BACK FLOW OF CRUDE OIL IN THE  
 4" ILLEGAL THEFT PIPE CONNECTED TO THE BUNKERING  
 FITTING.
