# JOINT INVESTIGATION REPORT

INCIDENT NO: 214 7124 JIV report S/N: 0080

1. Spill incident Number: 214 7124 2. Type of incident\*: OIL SPILL  
3. Name of Location: 12" IMO RIVER - OGALE PIPELINE  
4. Name of nearest community ODAGWA 5. State: RIVERS 6. LGA ETCHE  
7. Type of Production facility/Installation OIL PIPELINE  
8. Asset owner/District THE SHELL PETROLEUM DEVELOPMENT COMPANY OF NIGERIA LTD (SPDC) / PIPELINE

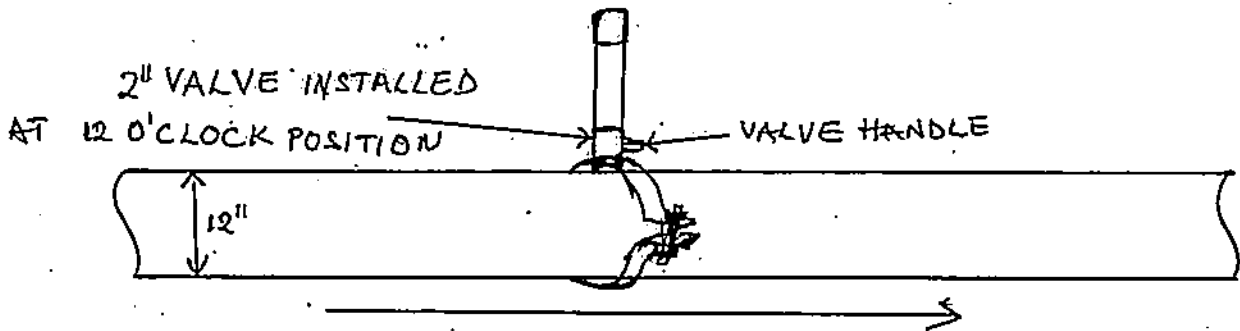
Additional observations around the spill point: THE JOINT INVESTIGATION TEAM SAW 2" VALVE CRUDE THEFT POINT INSTALLED AT 12 O'CLOCK POSITION BY UNKNOWN PERSONS.

E. GRAPHIC DESCRIPTION OF LEAK POINT (while detailed report of the leak point should be contained in the leak report, overview sketch of the site should be added as an appendix 1) A SECTION OF 12" IMD RIVER - OGALE PIPELINE AT ODAGWA SHOWING 2" BRIDE THEFT VALVE, INSTALLED AT 12 O'CLOCK POSITION BY UNKNOWN PERSONS.

REPAIR BY CLAMPING.
