JOINT INVESTIGATION REPORT

INCIDENT NO: 2135350 JIV report S/N: 0214

1. Spill incident Number: 2135350 2. Type of incident*: OIL SPILL
 3. Name of Location: 10" EMULSION LINE AT TANK 602
 4. Name of nearest community: OGULAGHA 5. State: DELTA 6. LGA: BURUTU
 7. Type of Production facility/Installation: OIL PIPELINE
 8. Asset owner/District: SHELL PETROLEUM DEVELOPMENT COMPANY OF NIGERIA LIMITED SWAMP WEST HUB

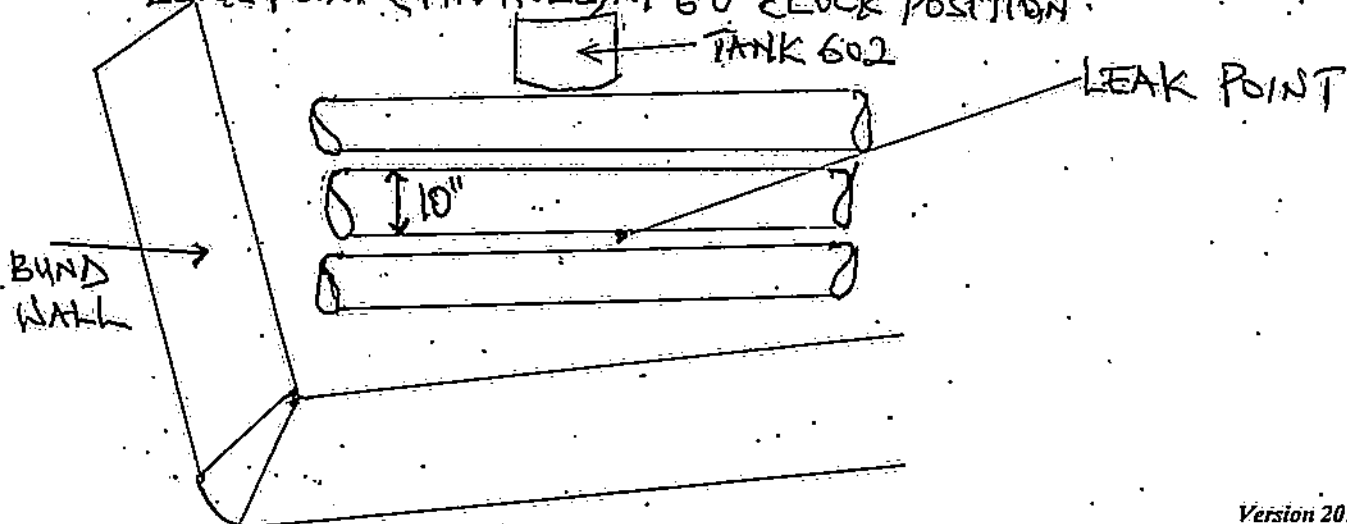
| <input checked="" type="checkbox"/> Corrosion | <input type="checkbox"/> Others(specify) _____ | |

E. GRAPHIC DESCRIPTION OF LEAK POINT (while detailed report of the leak point should be contained in the leak report, overview sketch of the site should be added as an appendix 1) **A SECTION OF 10" EMULSION LINE AT FORCADOS OIL TERMINAL TANK 602 SHOWING LEAK POINT (PIN HOLE) AT 6'O' CLOCK POSITION.**
