JOINT INVESTIGATION REPORT

INCIDENT NO: 2225804 JIV report S/N: 0196

1. Spill incident Number: 2225804 2. Type of incident* OIL SPILL
3. Name of Location 14" OKORAI - RUMUEKPE PIPELINE
4. Name of nearest community ULA- IKATA 5. State: RIVER 6. LGA AHOADA
7. Type of Production facility/Installation OIL PIPELINE
8. Asset owner/District THE SHELL PETROLEUM DEVELOPMENT COMPANY OF NIGERIA LTD (SPDC) PIPELINE

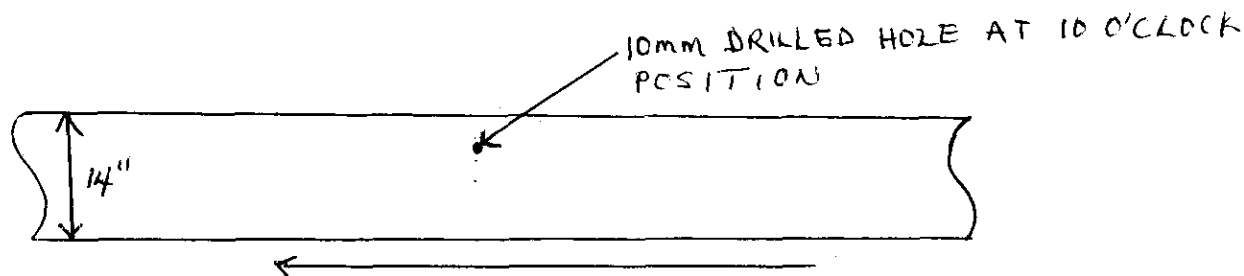
OKORDIA TO RUMUEKPE

| <input checked="" type="checkbox"/> Drilled hole | <input type="checkbox"/> Hack saw cut | <input type="checkbox"/> Tear (_____) |

- ☒ Third party interference (Sabotage☒; crude theft☐; Line theft☐; Accidental 3rd party damage☐
☐ Operational ☐ Mystery spills ☐ Others(specify) _____

E. GRAPHIC DESCRIPTION OF LEAK POINT (while detailed report of the leak point should be contained in the leak report, overview sketch of the site should be added as an appendix 1) **A SECTION OF 14" OKORDIA - RUMUEKPE PIPELINE AT ULA-IKATA SHOWING 10MM DRILLED HOLE AT 10 O'CLOCK POSITION BY UNKNOWN PERSONS.**

REPAIR BY CLAMPING
