# JOINT INVESTIGATION REPORT

INCIDENT NO: 2224449 JIV report S/N: 0192

1. Spill incident Number: 2224449 2. Type of incident\* OIL SPILL  
3. Name of Location 6" MININTA - AHIA BULKLINE  
4. Name of nearest community AKPARU 5. State: RIVERS 6. LGA EMOHUA  
7. Type of Production facility/Installation FLOWLINE  
8. Asset owner/District THE SHELL PETROLEUM DEVELOPMENT COMPANY OF NIGERIA LTD (SPDC) /

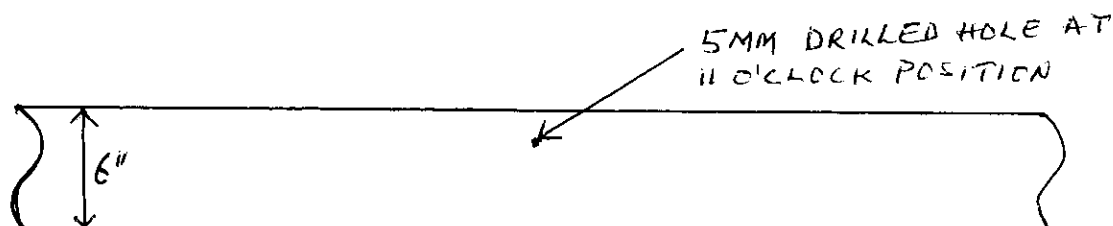
| <input checked="" type="checkbox"/> Drilled hole | <input type="checkbox"/> Hack saw cut | <input type="checkbox"/> Tear (_____) |

- ☒ Third party interference (Sabotage☒; crude theft☐; Line theft☐; Accidental 3<sup>rd</sup> party damage☐  
☐ Operational ☐ Mystery spills ☐ Others(specify) \_\_\_\_\_

E. GRAPHIC DESCRIPTION OF LEAK POINT (while detailed report of the leak point should be contained in the leak report, overview sketch of the site should be added as an appendix I) A SECTION OF 6" MININTA — AHIA BULKLINE AT ARPARU SHOWING 5mm DRILLED HOLE AT 11 O'CLOCK POSITION BY UNKNOWN PERSONS.
