JOINT INVESTIGATION REPORT

INCIDENT NO: 2018653 JIV report S/N: 1018

1. Spill incident Number: 2018653 2. Type of incident* OIL SPILL/FIRE
3. Name of Location 20" RUMUEKPE - NKPOKU PIPELINE
4. Name of nearest community OMUIGWE-ALUU 5. State: RIVERS 6. LGA IKWERRE
7. Type of Production facility/Installation OIL PIPELINE
8. Asset owner/District THE SHELL PETROLEUM DEVELOPMENT COMPANY OF NIGERIA LTD (SPDC) / PIPELINE

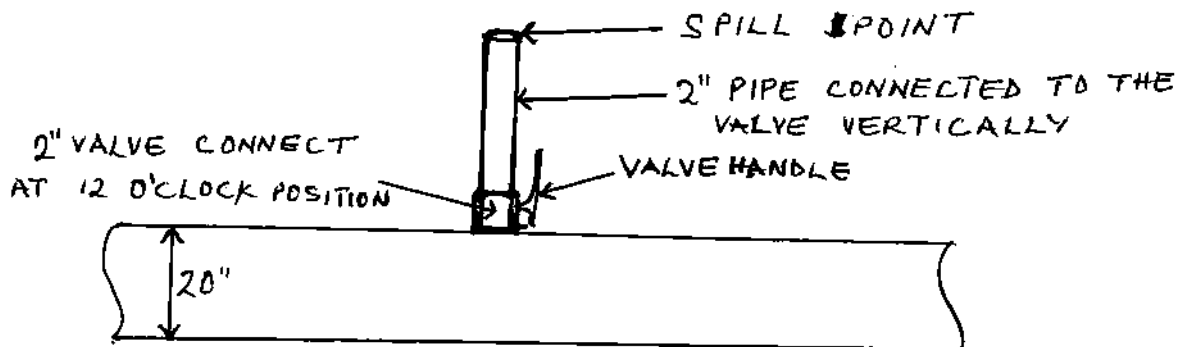
A SECTION OF 20" RUMUEKPE-NKPOKU PIPELINE AT ABARA SHOWING A 2" VALVE CRUDE THEFT POINT INSTALLED AT 12 O'CLOCK POSITION BY UNKNOWN PERSONS.

REPAIR BY CLAMPING
