# JOINT INVESTIGATION REPORT

INCIDENT NO: 2027350 JIV report S/N: 1114

1. Spill incident Number: 2027350 2. Type of incident\* OIL SPILL  
3. Name of Location 24" TRANS-ESCRAVOS PIPELINE  
4. Name of nearest community SOKEBOLU 5. State: DELTA 6. LGA BURUTU  
7. Type of Production facility/Installation OIL PIPELINE  
8. Asset owner/District THE SHELL PETROLEUM DEVELOPMENT COMPANY OF NIGERIA LIMITED / PIPELINES

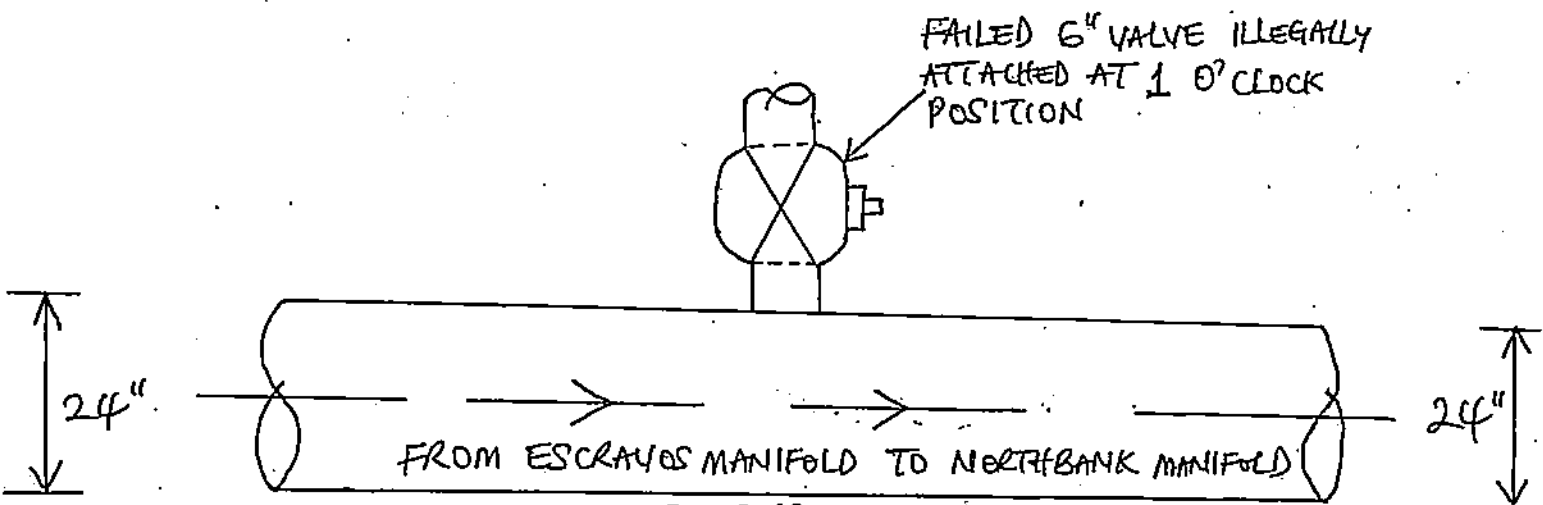
Additional observations around the spill point: DURING EXCAVATION, THE JOINT INVESTIGATION TEAM OBSERVED A FAILED 6" VALVE ILLEGALLY ATTACHED TO THE 24" TRANS-ESCRAVOS PIPELINE AT 1 O'CLOCK POSITION. THE LEAK WAS OBSERVED TO HAVE STOPPED AS AT THE TIME OF THIS INVESTIGATION.

**E. GRAPHIC DESCRIPTION OF LEAK POINT** (While detail report of the leak point should be contained in the leak report, overview sketch of the site should be added as an appendix I)  
SECTION OF 24" TRANS-ESCRAYOS PIPELINE AT SOKEBOLON AXIS  
SHOWING; A FAILED 6" VALVE ILLEGALLY ATTACHED AT 1 O'CLOCK POSITION
