# JOINT INVESTIGATION REPORT

INCIDENT NO: 2000801 JIV report S/N: 0994

1. Spill incident Number: 2000801 2. Type of incident\* OIL SPILL  
3. Name of Location 28" BOMU - BONNY TRANS NIGER PIPELINE  
4. Name of nearest community BODO WEST 5. State: RIVERS 6. LGA GOKANA  
7. Type of Production facility/Installation OIL PIPELINE  
8. Asset owner/District THE SHELL PETROLEUM DEVELOPMENT COMPANY OF NIGERIA LIMITED

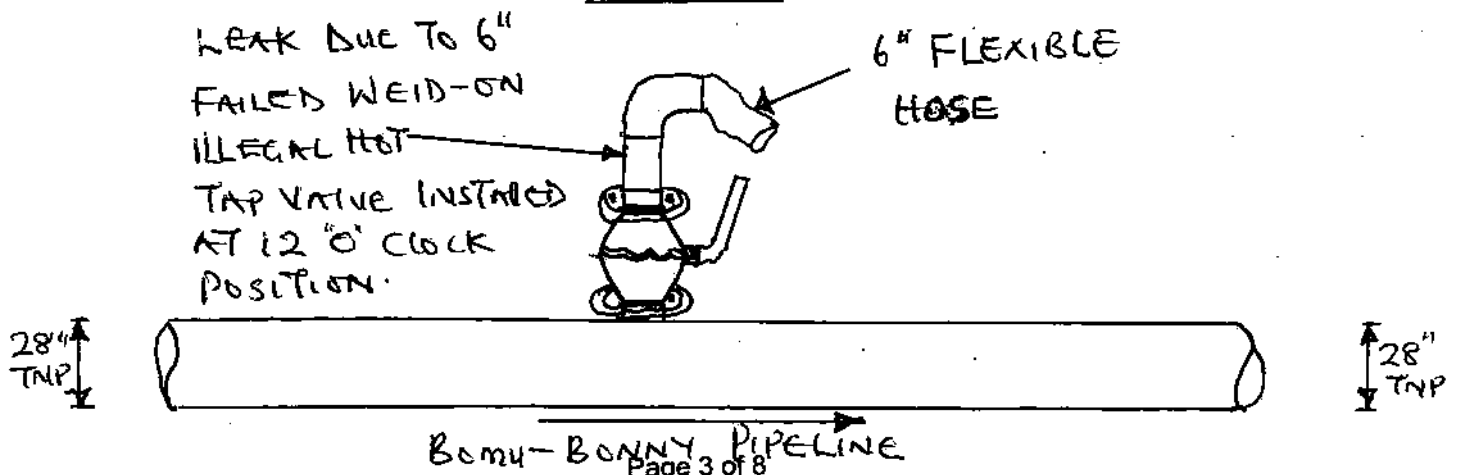
| <input checked="" type="checkbox"/> Failed Weld-on illegal hot tap valve | <input type="checkbox"/> Failed Clamp, | <input type="checkbox"/> Missing Pipeline/Flowline |
| <input checked="" type="checkbox"/> Crude oil theft (illegal bunkering) point, | <input type="checkbox"/> Saver-pit over flow | <input type="checkbox"/> Third party tampering with Clamp |

- ☒ Third party interference (Sabotage ☐; crude theft ☒; Line theft ☐; Accidental 3<sup>rd</sup> party damage ☐  
☐ Operational ☐ Mystery spills ☐ Others(specify) \_\_\_\_\_

SECTIONAL VIEW OF 28" BOMU - BONNY TRANS NIGER PIPELINE AT  
BODDO WEST SHOWING:- FAILED 6" WELD-ON ILLEGAL HOT  
TAP VALVE.

RECOVERY WORK AND REPAIR WORK BY CLAMPING  
ONGOING

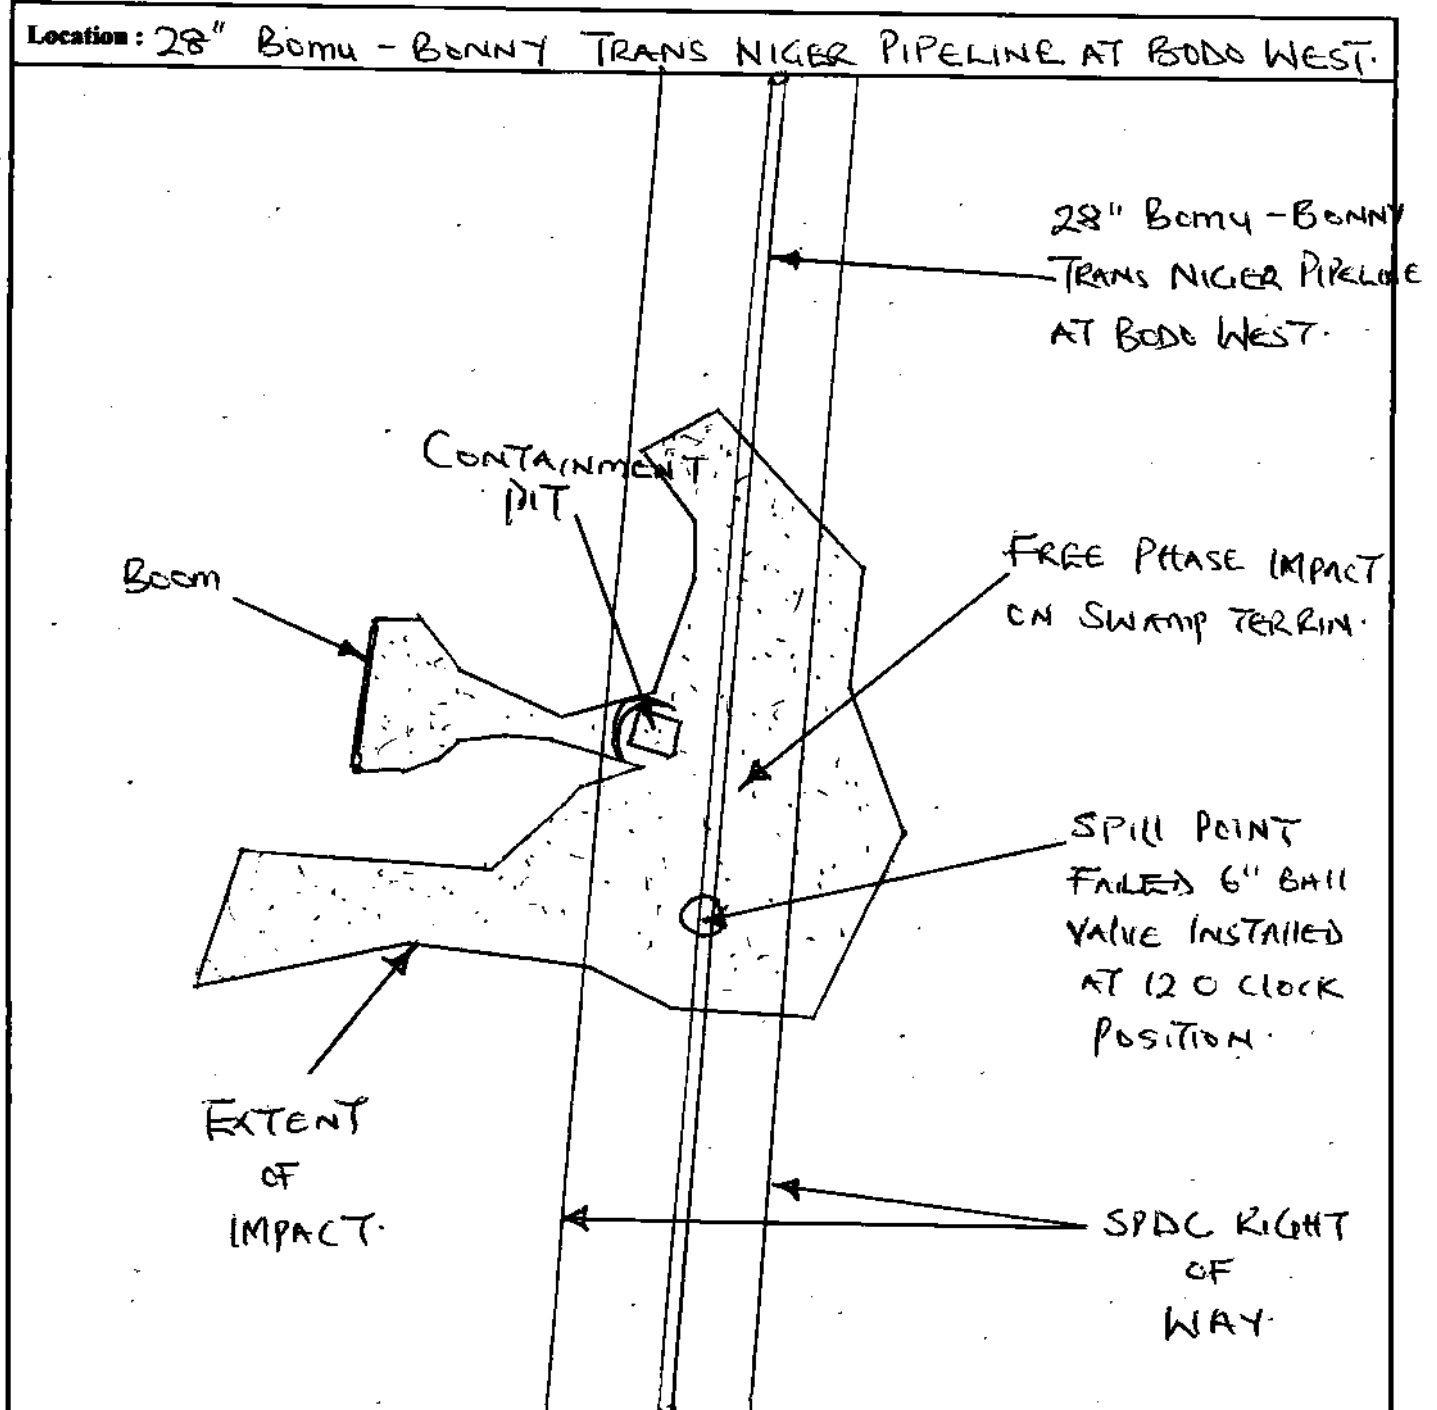
f. Appendix 1: Overview sketch of the site

- Total calculated area of impact 0.259216 Ha (0.26 Ha)
- Impact within R.O.W YES
- Impact outside R.O.W YES
