# JOINT INVESTIGATION REPORT

INCIDENT NO: 2000229 JIV report S/N: 0917

1. Spill incident Number: 2000229 2. Type of incident\* OIL SPILL  
3. Name of Location AGBADA WELL 18 T FLOWLINE  
4. Name of nearest community OMUNIKE (OMUNOBO) 5. State: RIVERS 6. LGA IKWERRE  
7. Type of Production facility/Installation OIL FLOWLINE  
8. Asset owner/District THE SHELL PETROLEUM DEVELOPMENT COMPANY OF NIGERIA LIMITED / LAND EAST HUB

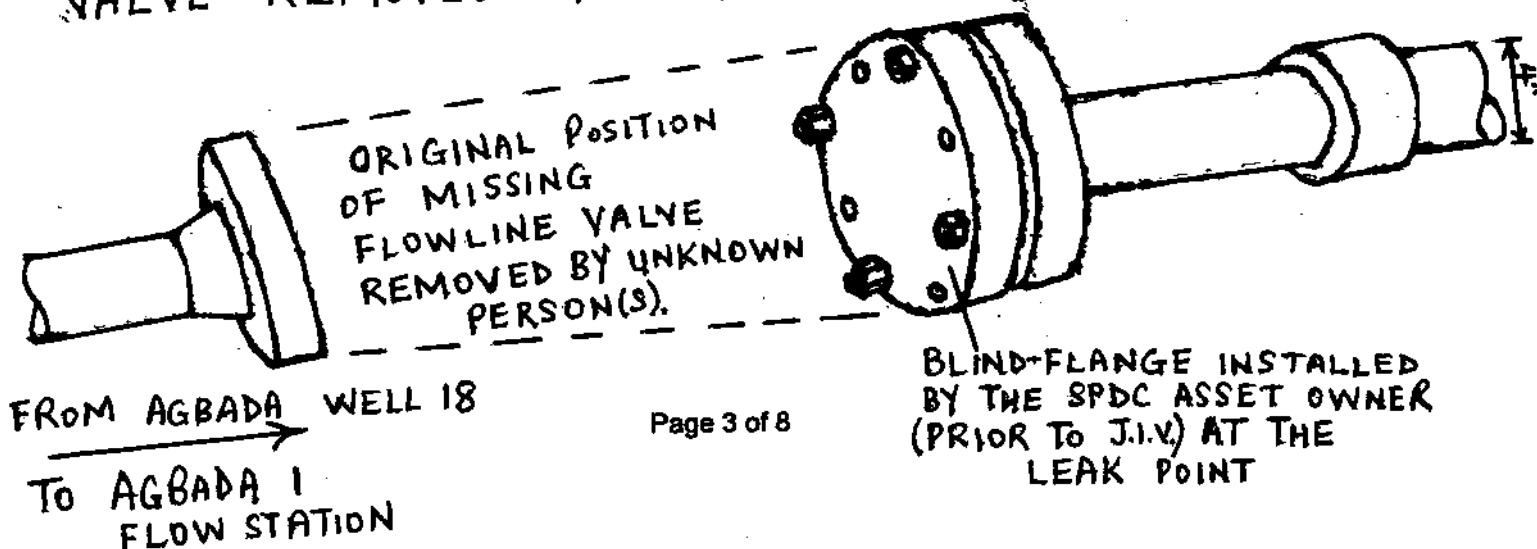
Additional observations around the spill point: **SPILL WAS OBSERVED WITHIN AN ONGOING REMEDIATED SITE. THE JOINT INVESTIGATION TEAM, ON ARRIVAL AT SITE, NOTICED THAT THE SPILL POINT (OCCASIONED BY THE MISSING FLOWLINE VALVE ON AGBADA WELL 18 T FLOWLINE) HAD BEEN BLIND-FLANGED BY THE ASSET OWNER AS A MEANS OF POSITIVE ISOLATION. THE ADJACENT AGBADA WELL 13 FLOWLINE HAD ITS VALVE STILL IN PLACE.**

| <input type="checkbox"/> Corrosion | <input checked="" type="checkbox"/> Others(specify) <b>FLOWLINE VALVE THEFT BY UNKNOWN PERSON(S).</b> | |

SECTION OF AGBADA WELL 18T FLOW LINE AT SOKU SHOWING EVIDENCE OF MISSING FLOW LINE VALVE REMOVED BY UNKNOWN PERSON(S).
