JOINT INVESTIGATION REPORT

INCIDENT NO: 2000189 JIV report S/N: 0940

1. Spill incident Number: 2000189 2. Type of incident* OIL SPILL
3. Name of Location ADIBAWA FLOW STATION FLARE STACK
4. Name of nearest community EDAGBERI 5. State: RIVERS 6. LGA AHOADA WEST
7. Type of Production facility/Installation FLOW STATION
8. Asset owner/District THE SHELL PETROLEUM DEVELOPMENT COMPANY OF NIGERIA (SPDC)/LAND CENTRAL HUB

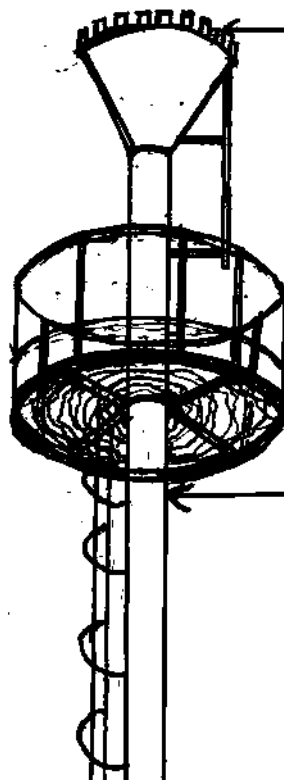
| <input checked="" type="checkbox"/> Flare System/Bund wall failure | <input type="checkbox"/> Cold vent | <input type="checkbox"/> Surge vessel overflow, |

SPILL POINT

A SECTION OF ADIBAWA
FLOW STATION FLARE
STACK AT EDAGBARI
SHOWING SPILL POINT

RECOVERY OF FREE PHASE OIL,

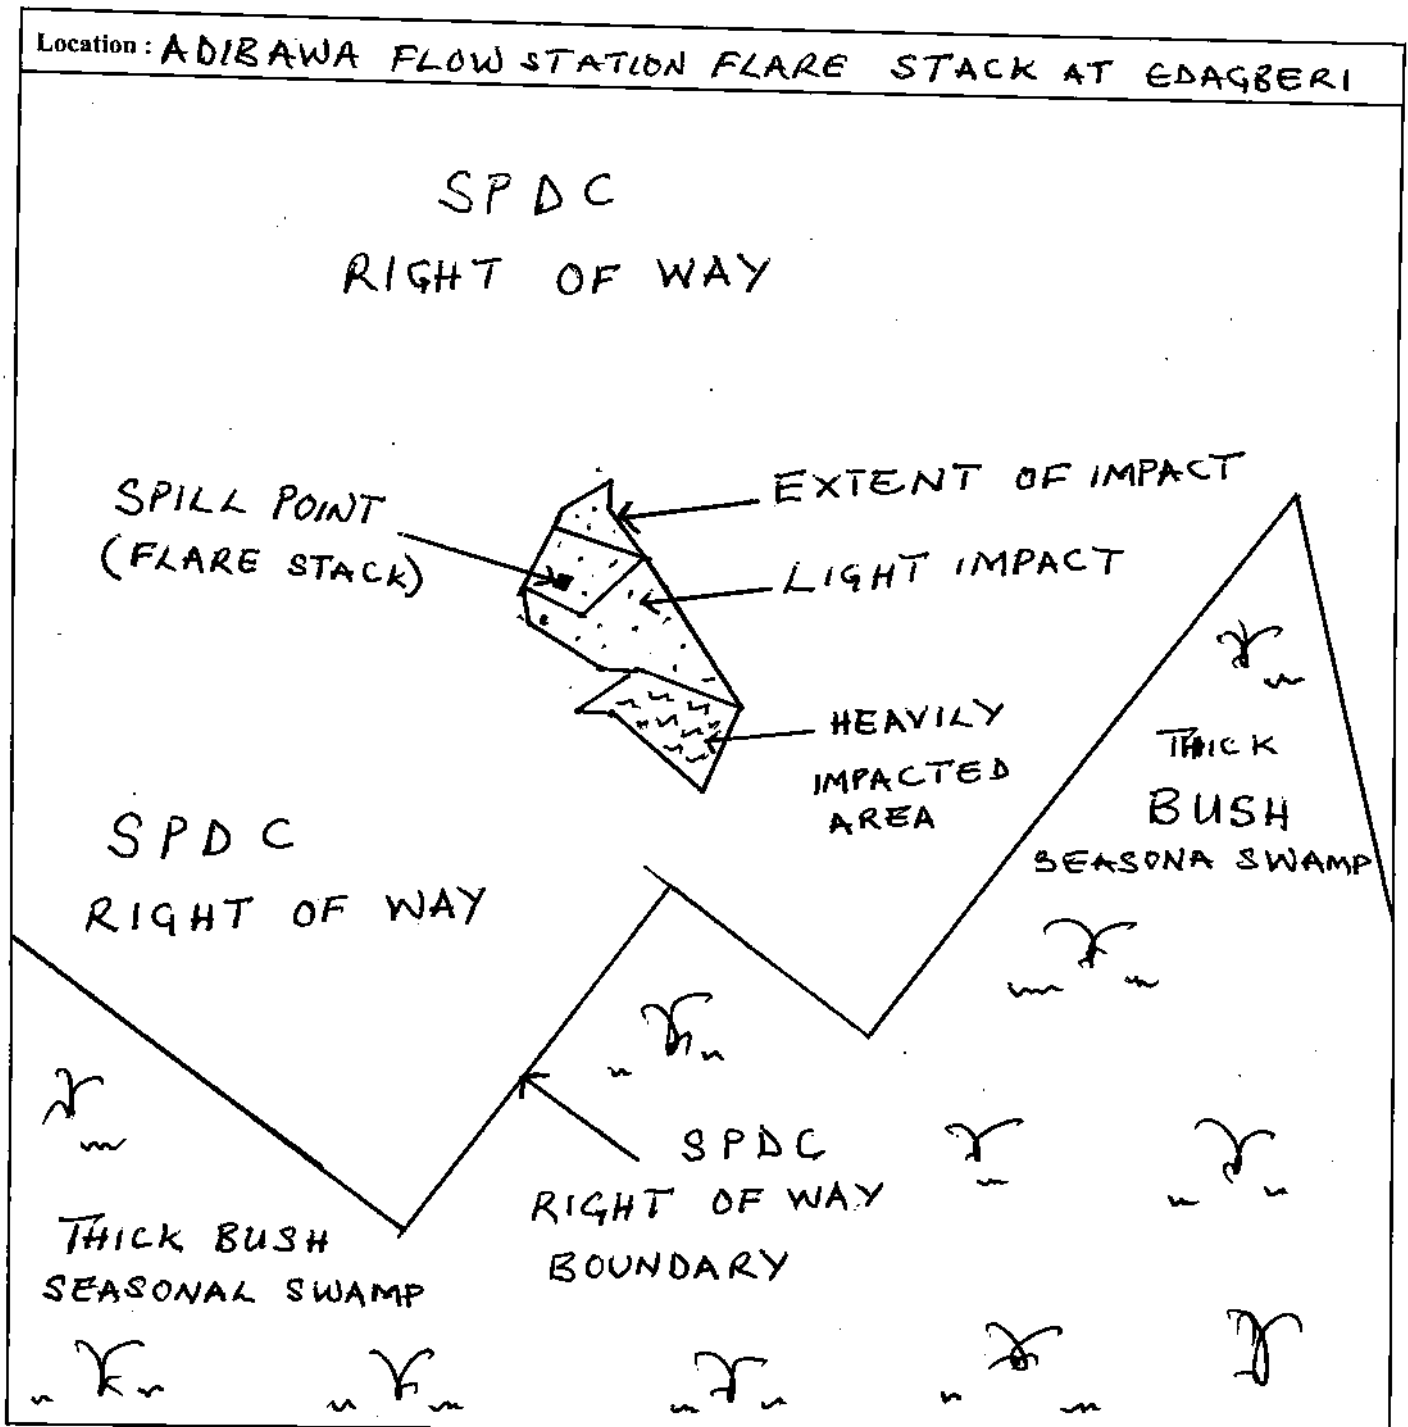
f. Appendix 1: Overview sketch of the site

- Total calculated area of impact 0.092138 Ha (0.092 Ha)
- Impact within R.O.W YES
- Impact outside R.O.W NIL
