JOINT INVESTIGATION REPORT

INCIDENT NO: 2115800 JIV report S/N: 0001

1. Spill incident Number: 2115800 2. Type of incident* OIL SPILL
3. Name of Location 12" / MB. RIVER 2 - OGALE TRUNKLINE ROW.
IGIRIKWU
4. Name of nearest community ISHEITIOHA 5. State: ABIA 6. LGA UKWA - WEST
7. Type of Production facility/Installation PIPELINE
8. Asset owner/District THE SHELL PETROLEUM DEVELOPMENT COMPANY OF NIGERIA LIMITED.

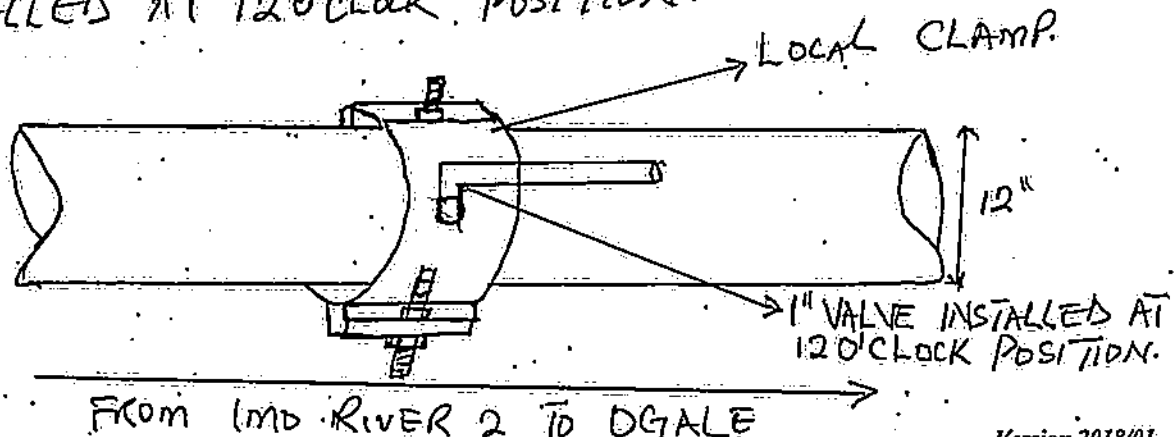
Additional observations around the spill point: THE JOINT INVESTIGATION TEAM OBSERVED ONE NUMBER ILLEGAL (THEFT) FITTING WITH LOCALLY FABRICATED CLAMP INSTALLED BY UNKNOWN PERSON(S).

| <input checked="" type="checkbox"/> Failed Weld-on illegal hot tap valve | <input type="checkbox"/> Failed Clamp | <input type="checkbox"/> Missing Pipeline/Flowline |
| <input checked="" type="checkbox"/> Crude oil theft (illegal bunkering) point | <input type="checkbox"/> Saver-pit over flow | <input type="checkbox"/> Third-party tampering with Clamp |

A SECTION OF 12" INDIAN RIVER 2 - OGALE TRUNKLINE AT IGIRUKWU/ISICETI/IDHA, SHOWING LOCALLY FABRICATED CLAMP AND A 1" VALVE INSTALLED AT 12 O'CLOCK POSITION.
