JOINT INVESTIGATION REPORT

INCIDENT NO: 2119145 JIV report S/N: 1095

1. Spill incident Number: 2119145 2. Type of incident* OIL SPILL
3. Name of Location 16" NUN RIVER - KOLD CREEK PIPELINE
4. Name of nearest community OPOROMA 5. State: BAYELSA 6. LGA SOUTHERN IJAW
7. Type of Production facility/Installation OIL PIPELINE
8. Asset owner/District THE SHELL PETROLEUM DEVELOPMENT COMPANY OF NIGERIA LTD (SPDC) / PIPELINE

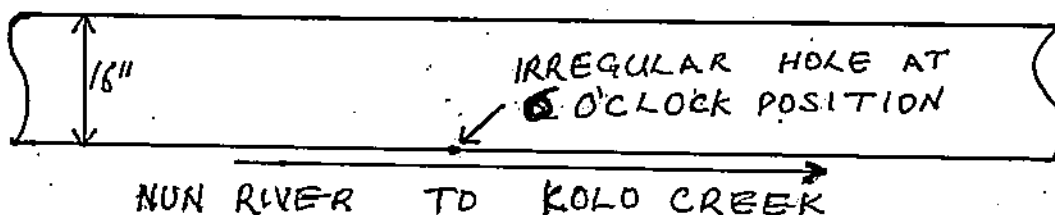
Additional observations around the spill point: THE TEAM OBSERVED AN IRREGULAR HOLE AT 6 O'CLOCK POSITION.

| <input checked="" type="checkbox"/> Corrosion | <input type="checkbox"/> Others(specify) _____ | |

E. GRAPHIC DESCRIPTION OF LEAK POINT (While detail report of the leak point should be contained in the leak report, overview sketch of the site should be added as an appendix.) A SECTION OF 16" NUN RIVER - KOLO CREEK PIPELINE AT OPOROMA SHOWING AN IRREGULAR HOLE AT 6 O'CLOCK POSITION DUE TO CORROSION.
