JOINT INVESTIGATION REPORT

INCIDENT NO: 2125542 JIV report S/N: 1137

1. Spill incident Number: 2125542 2. Type of incident* OIL SPILL
3. Name of Location AGBAYA WELL 1 WELL HEAD
4. Name of nearest community OGBOTOBO / AGBAYANA 5. State: BAYELSA 6. LGA EKEREMOR
7. Type of Production facility/Installation WELL HEAD
8. Asset owner/District THE SHELL PETROLEUM DEVELOPMENT COMPANY OF NIGERIA LIMITED / SWAMP WEST

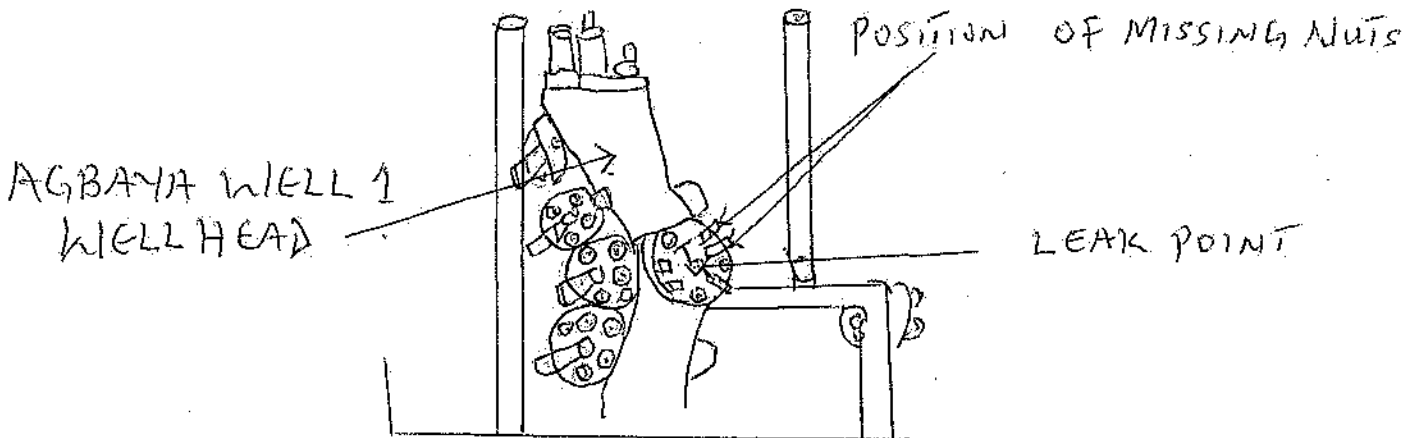
SECTION OF AGBAYA WELL 1 WELLHEAD AT OGBOTOBO/AGBAYAMA SHOWING POSITION OF LEAK POINT

FIVE MISSING NUTS FROM AGBAYA WELL 1 WELL HEAD WAS OBSERVED BY THE JOINT INVESTIGATION TEAM.

| <input type="checkbox"/> Complete Rupture | <input type="checkbox"/> Inward dent, | <input checked="" type="checkbox"/> Well head tampering |
