JOINT INVESTIGATION REPORT

INCIDENT NO: 2125779 JIV report S/N: 0020

1. Spill incident Number: 2125779 2. Type of incident* OIL SPILL
3. Name of Location 20" KOLOCREEK - RUMUEKPE (TRUNKLINE) PIPELINE
4. Name of nearest community RUMUEKPE 5. State: RIVERS 6. LGA EMOHUA
7. Type of Production facility/Installation OIL PIPELINE
8. Asset owner/District THE SHELL PETROLEUM DEVELOPMENT COMPANY OF NIGERIA LIMITED PIPELINE

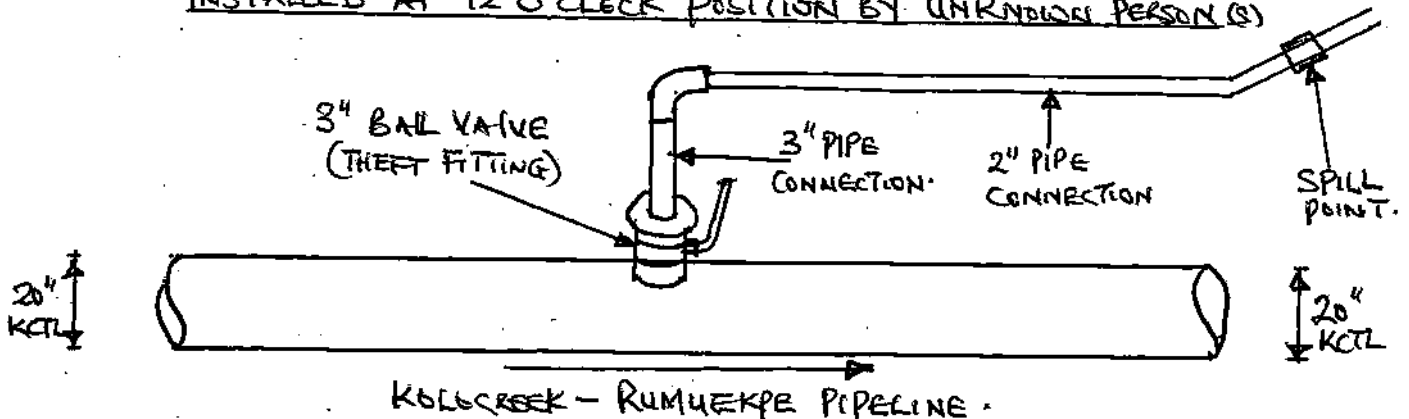
E. GRAPHIC DESCRIPTION OF LEAK POINT (while detailed report of the leak point should be contained in the leak report, overview sketch of the site should be added as an appendix 1)

Additional observations around the spill point: THE JOINT INVESTIGATION TEAM OBSERVED AN ILLEGAL 2" PIPE CONNECTED TO THE THEFT FITTING INSTALLED AT 12'O'CLOCK POSITION ON THE 20" KCTL AT RUMUEKPE BY UNKNOWN PERSON(S). THE SPILL POINT WAS OBSERVED OUTSIDE SPDC RIGHT OF WAY ON THE 2" PIPE CONNECTION'

SECTIONAL VIEW OF 20" KOLOCREEK - RUMUEKPE (TRUNKLINE) PIPELINE AT RUMUEKPE. SHOWING ONE (1) 3" BALL VALVE FLANGE FITTING INSTALLED AT 12 O'CLOCK POSITION BY UNKNOWN PERSON(S)

TEMPORARY REPAIR BY BLIND FLANGING COMPLETED
WHILE RECOVERY WORK IS ONGOING.
