JOINT INVESTIGATION REPORT

INCIDENT NO: 2129739 JIV report S/N: 0029

1. Spill incident Number: 2129739 2. Type of incident* DIL SPILL
3. Name of Location 24" NKPOKU — BOMU PIPELINE
4. Name of nearest community SIME 5. State: RIVERS 6. LGA TAI
7. Type of Production facility/Installation DIL PIPELINE
8. Asset owner/District THE SHELL PETROLEUM DEVELOPMENT COMPANY OF NIGERIA LIMITED/PIPELINE.

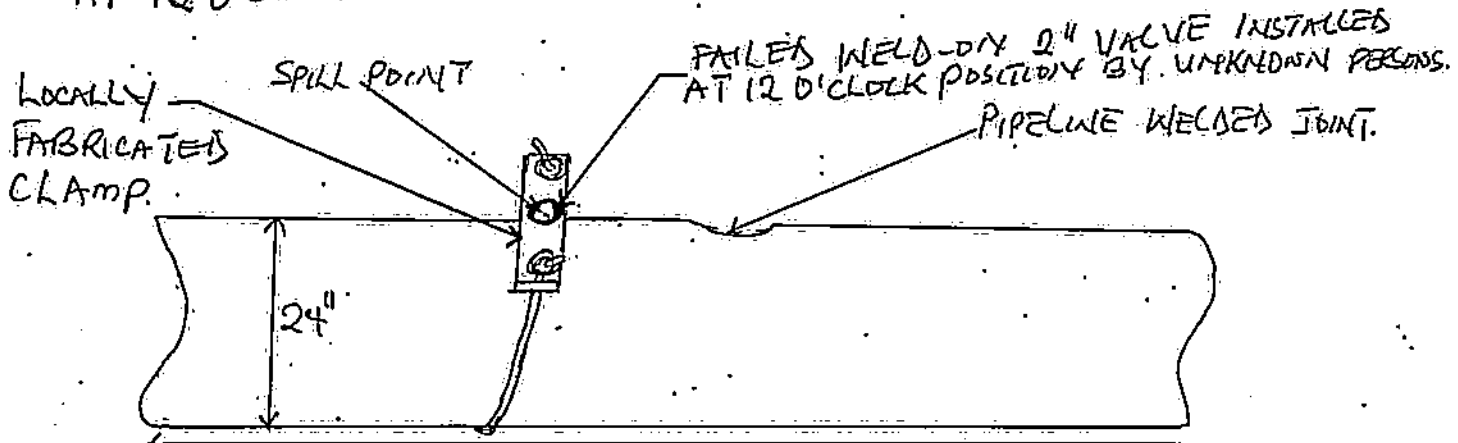
Additional observations around the spill point: THE JOINT INVESTIGATION TEAM OBSERVED A FAILED WELD-ON 2" VALVE AND A LOCALLY FABRICATED CLAMP AT 12 O'CLOCK POSITION.

E. GRAPHIC DESCRIPTION OF LEAK POINT (while detailed report of the leak point should be contained in the leak report, overview sketch of the site should be added as an appendix 1) A SECTION OF 24" NIKOTKU-BONNU PIPELINE AT SOME STATION BY A FAILED WELD-DIY ILLEGAL VALVE CONNECTION WITH A LOCALLY FABRICATED CLAMP INSTALLED AT 12 O'CLOCK POSITION BY UNKNOWN PERSON(S).

CRUDE OIL RECOVERY AND REPAIR BY CLAMPING ARE ONGOING.
