JOINT INVESTIGATION REPORT

INCIDENT NO: 2127108 JIV report S/N: 0007

1. Spill incident Number: 2127108 2. Type of incident* OIL SPILL
3. Name of Location 20" RUMUEKPE - NKPOKU PIPELINE
4. Name of nearest community I B A A 5. State: RIVERS 6. LGA EMOHUA
7. Type of Production facility/Installation OIL PIPELINE
8. Asset owner/District THE SHELL PETROLEUM DEVELOPMENT COMPANY OF NIGERIA LTD (SPDC) / PIPELINE

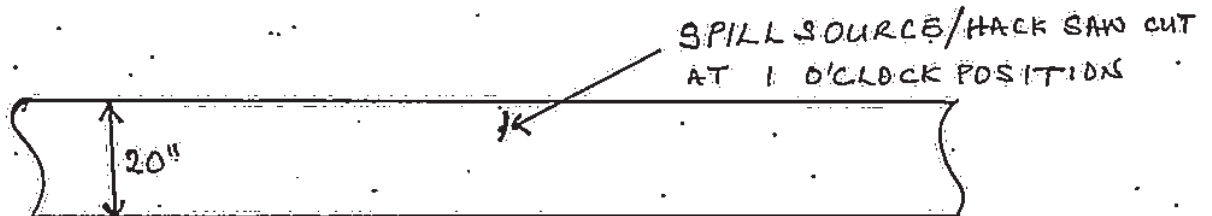
Additional observations around the spill point: THE JOINT INVESTIGATION TEAM SAW HACK SAW CUT AT 1 O'CLOCK POSITION

E. GRAPHIC DESCRIPTION OF LEAK POINT (while detailed report of the leak point should be contained in the leak report, overview sketch of the site should be added as an appendix 1) A SECTION OF 20"

RUMUEKPE - NKPOKU PIPELINE AT IBAA SHOWING HACK SAW CUT AT 1 O'CLOCK POSITION DONE BY UNKNOWN PERSONS

SPILL RESPONSE AND LEAK REPAIR
