JOINT INVESTIGATION REPORT

INCIDENT NO: 2129948 JIV report S/N: 0028

1. Spill incident Number: 2129948 2. Type of incident* DIL SPILL
 3. Name of Location: 12" INDIAN RIVER - OGALE PIPELINE
 4. Name of nearest community OGALE 5. State: RIVERS 6. LGA ELEME
 7. Type of Production facility/Installation DIL PIPELINE
 8. Asset owner/District THE SHELL PETROLEUM DEVELOPMENT COMPANY OF NIGERIA LIMITED PIPELINE

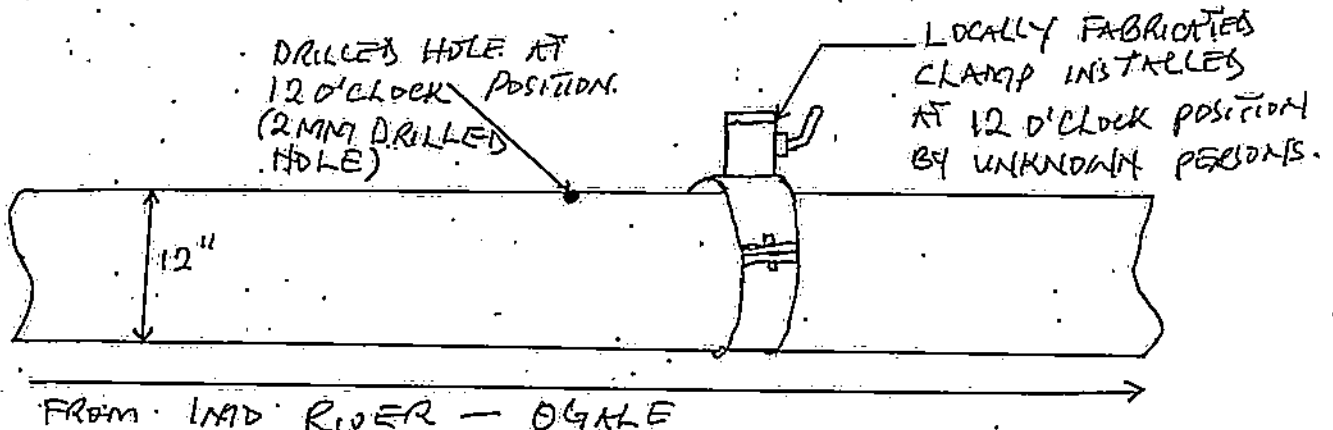
Additional observations around the spill point: THE JOINT INVESTIGATION TEAM OBSERVED A DRILLED HOLE AND A LOCALLY FABRICATED CLAMP WITH 1" VALVE INSTALLED BOTH AT 12 O'CLOCK POSITION BY UNKNOWN PERSONS. THE JOINT INVESTIGATION TEAM ALSO OBSERVED BURNT SOIL WITHIN THE LEAK POINT AREA.

E. GRAPHIC DESCRIPTION OF LEAK POINT (while detailed report of the leak point should be contained in the leak report, overview sketch of the site should be added as an appendix 1) A SECTION OF 12" INDIAN RIVER - OGALÉ PIPELINE AT OGALÉ SHOWING A DRILLED HOLE AT 12 O'CLOCK POSITION AND A LOCALLY FABRICATED CLAMP WITH 1" VALVE INSTALLED BY UNKNOWN PERSON(S).

REPAIR BY CLAMPING ONGONG.
