JOINT INVESTIGATION REPORT

INCIDENT NO: 2122482 JIV report S/N: 0011

1. Spill incident Number: 2122482 2. Type of incident* OIL SPILL
 3. Name of Location QD⁶ RUMUEKPE - NKPOKU PIPELINE
 4. Name of nearest community MBODS - ALUS, State: RIVERS G.LGA IKWERRE
 7. Type of Production facility/Installation OIL PIPELINE
 8. Asset owner(s)/District THE SHELL PETROLEUM DEVELOPMENT COMPANY OF NIGERIA LIMITED / PIPELINE.

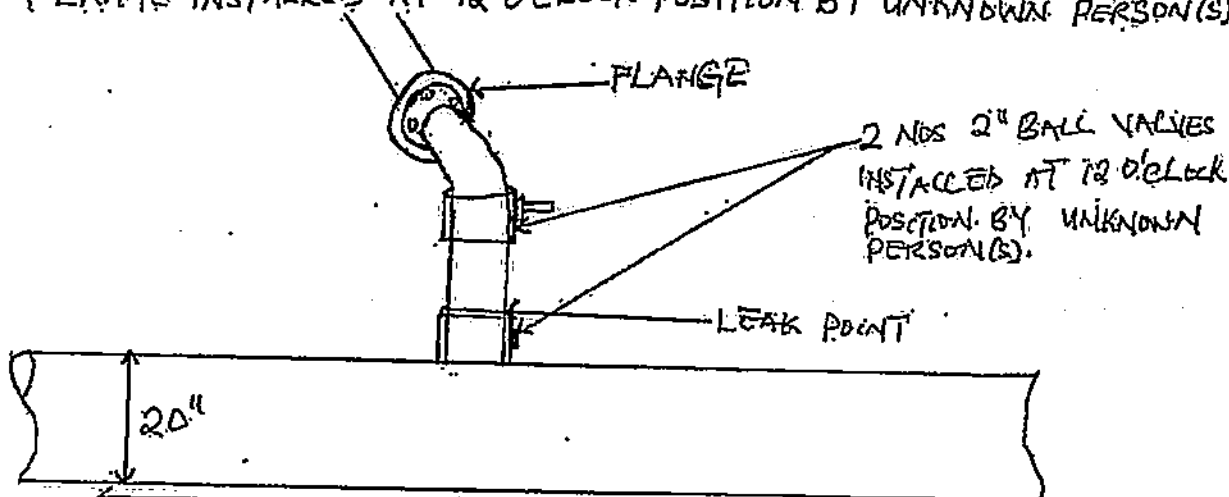
Additional observations around the spill point: THE INCIDENT WAS REPORTED AS A NOISE LEAKING POINT. DURING EXCAVATION OF THE ILLEGAL CONNECTION POINT, THE JOINT INVESTIGATION TEAM OBSERVED A FAILED WELD-ON ILLEGAL VALVE CONNECTION INSTALLED AT 12 O'CLOCK POSITION BY UNKNOWN PERSON(S). SAID BAGS WERE USED TO SUPPORT THE ILLEGAL CONNECTION.

E. GRAPHIC DESCRIPTION OF LEAK POINT (while detailed report of the leak point should be contained in the leak report, overview sketch of the site should be added as an appendix 1) A SECTION OF 20" RUNNUEKPE-NKPOKU PIPELINE AT MIBODO-ABUU SHOWING 2 NOS 2" BALL VALVES AND A FLANGE INSTALLED AT 12 O'CLOCK POSITION BY UNKNOWN PERSON(S).

REPAIR BY CLAMPING
