JOINT INVESTIGATION REPORT

INCIDENT NO: 2130768 JIV report S/N: 0018

1. Spill incident Number: 2130768 2. Type of incident* OIL SPILL
3. Name of Location 16" NUN RIVER - KOLOCREEK PIPELINE
4. Name of nearest community OTUEGWE IS. State: BAYELSA. LGA OGBIA
7. Type of Production facility/Installation OIL PIPELINE
8. Asset owner/District THE SHELL PETROLEUM DEVELOPMENT COMPANY OF NIGERIA LTD (SPDC) / PIPELINE

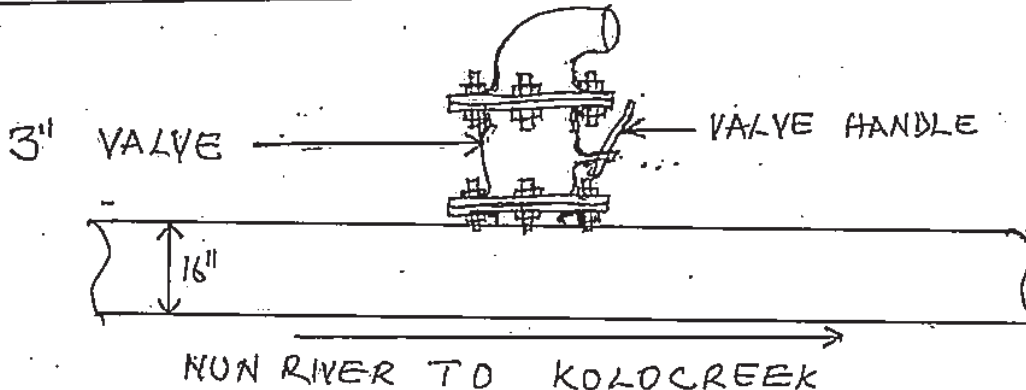
Additional observations around the spill point: THE JOINT INVESTIGATION TEAM SAW 3" VALVE CRUDE THEFT POINT INSTALLED AT 12 O'CLOCK POSITION.

E. GRAPHIC DESCRIPTION OF LEAK POINT (while detailed report of the leak point should be contained in the leak report, overview sketch of the site should be added as an appendix 1) A SECTION OF 16" NUN RIVER - KOLOCREEK PIPELINE AT OTUEGWEI SHOWING 3" VALVE CRUDE THEFT POINT INSTALLED AT 12 O'CLOCK POSITION BY UNKNOWN PERSONS

SPILL RESPONSE AND LEAK REPAIR
