JOINT INVESTIGATION REPORT

INCIDENT NO: 2096594 JIV report S/N: 1069

A. GENERAL INFORMATION:

**SECTIONAL VIEW OF 10" DIEBU CREEK - Nun River (D/L) PIPELINE
AT OPOROMA SHOWING MULTIPLE CUTS BY UNKNOWN
PERSON (S)**

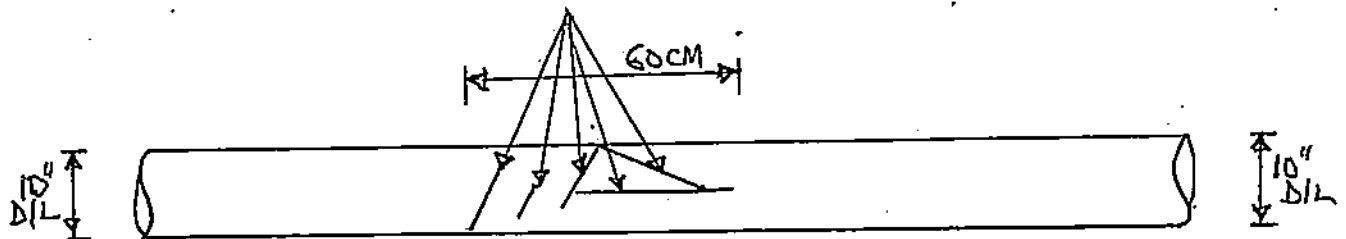
DIEBU CREEK - Nun RIVER PIPELINE

| <input type="checkbox"/> Drilled hole | <input checked="" type="checkbox"/> Hack saw cuts | <input type="checkbox"/> Tear (_____), |

- Third party interference (Sabotage ; crude theft ; Line theft ; Accidental 3rd party damage
 Operational Mystery spills Others(specify) _____

LEAK DUE TO
MULTIPLE CUTS

REPAIR WORK BY SECTIONAL REPLACEMENT ON-GOING.
