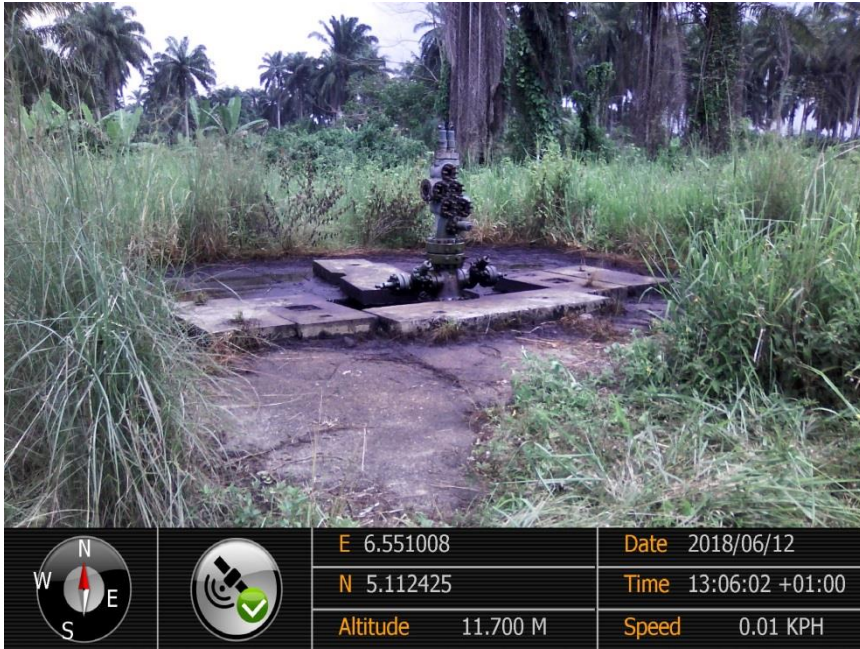
**Overview:** Part of spill impact Ubie Well 5 L/S Well head at Idu-Ekpeye. Picture was taken during Joint Investigation of 12<sup>th</sup> June 2018.

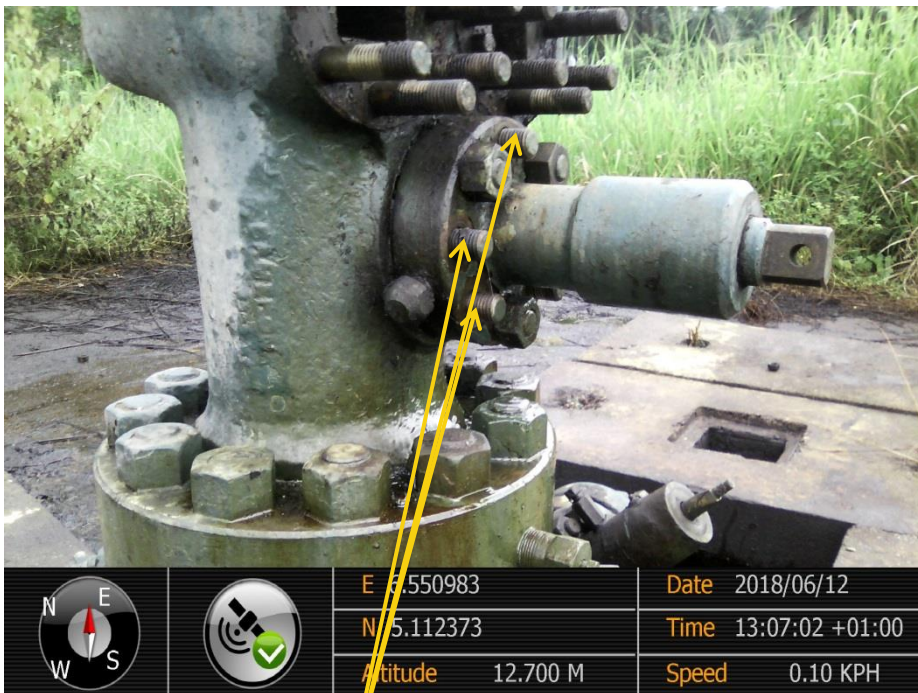
**Close-up:** Tampered Master Valve bolts on Ubie Well 5 L/S Well head at Idu-Ekpeye. Picture was taken during Joint Investigation of 12<sup>th</sup> June 2018.
