JOINT INVESTIGATION REPORT

INCIDENT NO: 2098739 JIV report S/N: 1080

1. Spill incident Number: 2098739 2. Type of incident* OIL SPILL
3. Name of Location 14th OKORDIA - RUMUEKPE PIPELINE
4. Name of nearest community ULA-IKATA 5. State: RIVERS 6. LGA AHOADA - EAST
7. Type of Production facility/Installation OIL PIPELINE
8. Asset owner/District THE SHELL PETROLEUM DEVELOPMENT COMPANY OF NIGERIA LIMITED / PIPELINE

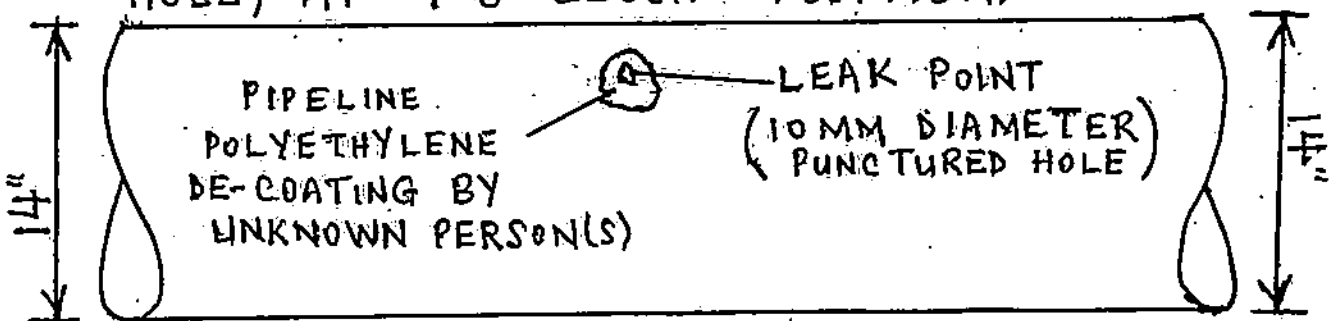
Additional observations around the spill point: **A SECTION OF THE PIPELINE POLYETHYLENE COATING SURROUNDING THE SPILL POINT WAS NOTICED TO HAVE BEEN REMOVED BY UNKNOWN PERSON(S).**

| <input type="checkbox"/> Corrosion | <input checked="" type="checkbox"/> Others(specify) <u>PUNCTURED HOLE</u> | |

SECTION OF 14" OKORDIA - RUMUEKPE PIPELINE
AT ULA-IKATA SHOWING LEAK POINT (PUNCTURED
HOLE) AT 1 O' CLOCK POSITION.
