JOINT INVESTIGATION REPORT

INCIDENT NO: 2100999 JIV report S/N: 1085

1. Spill incident Number: 2100999 2. Type of incident* OIL SPILL
3. Name of Location 8" UMUECHEM - NKPOKU PIPELINE
4. Name of nearest community OMUNWEI 5. State: RIVERS 6. LGA IKWERRE
7. Type of Production facility/Installation OIL PIPELINE
8. Asset owner/District THE SHELL PETROLEUM DEVELOPMENT COMPANY OF NIGERIA LTD (SPDC) / PIPELINE

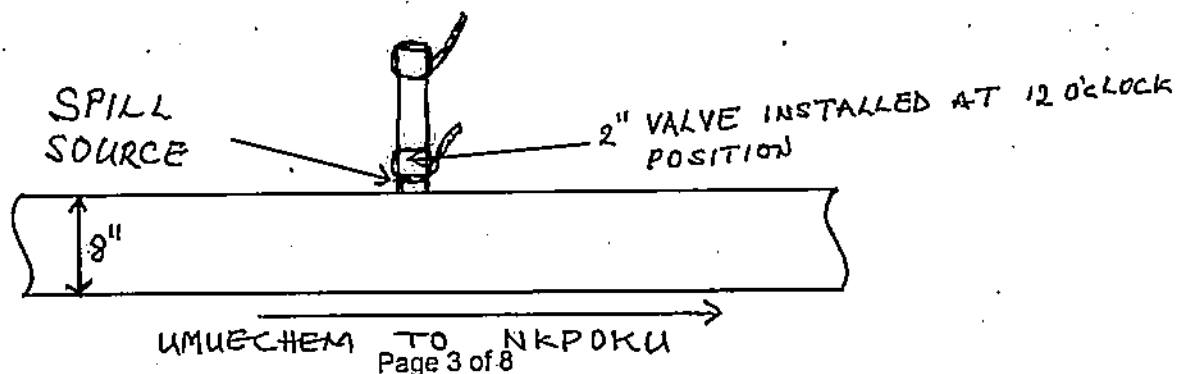
Additional observations around the spill point: THE JOINT INVESTIGATIONS TEAM SAW A CRUDE THEFT POINT (2" VALVE) INSTALLED AT 12 O'CLOCK POSITION.

8" UMUECHEM - NKPOKU PIPELINE AT OMUNWEI SHOWING A 2" VALVE CRUDE THEFT POINT INSTALLED AT 12 O'CLOCK POSITION BY UNKNOWN PERSON
