JOINT INVESTIGATION REPORT

INCIDENT NO: 2097259 JIV report S/N 1084

1. Spill incident Number: 2097259 2. Type of incident* OIL SPILL
3. Name of Location UBIE WELL 5 L/S WELL HEAD
4. Name of nearest community IDU-EKPEYE 5. State: RIVERS 6. LGA MBADA WEST
7. Type of Production facility/Installation WELL HEAD
8. Asset owner/District THE SHELL PETROLEUM DEVELOPMENT COMPANY OF NIGERIA

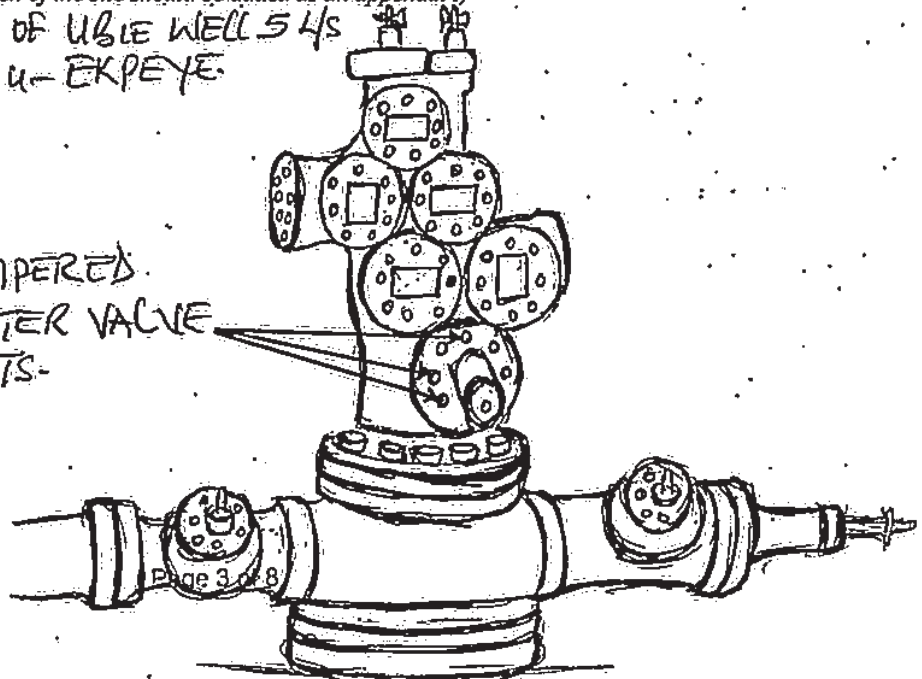
SECTIONAL VIEW OF UBLE WELL 545
WELLHEAD AT IDU-EKPEYE

Additional observations around the spill point: THE JOINT INVESTIGATION TEAM OBSERVED THAT UBIE WELL 5 XMAS TREE HAD BEEN VANDALIZED.

TAMPERS
MASTER VALVE
BOLTS-
