JOINT INVESTIGATION REPORT

INCIDENT NO: 2104692 JIV report S/N: 1083

1. Spill incident Number: 2104692 2. Type of incident* OIL SPILL
3. Name of Location 18th ASSA — RUMUEKPE TRUNKLINE AT ONJUDIOGA
4. Name of nearest community ONJUDIOGA 5. State: RIVERS 6. LGA EMBUHUA
7. Type of Production facility/Installation PIPELINE
8. Asset owner/District THE SHELL PETROLEUM DEVELOPMENT COMPANY OF NIGERIA LIMITED

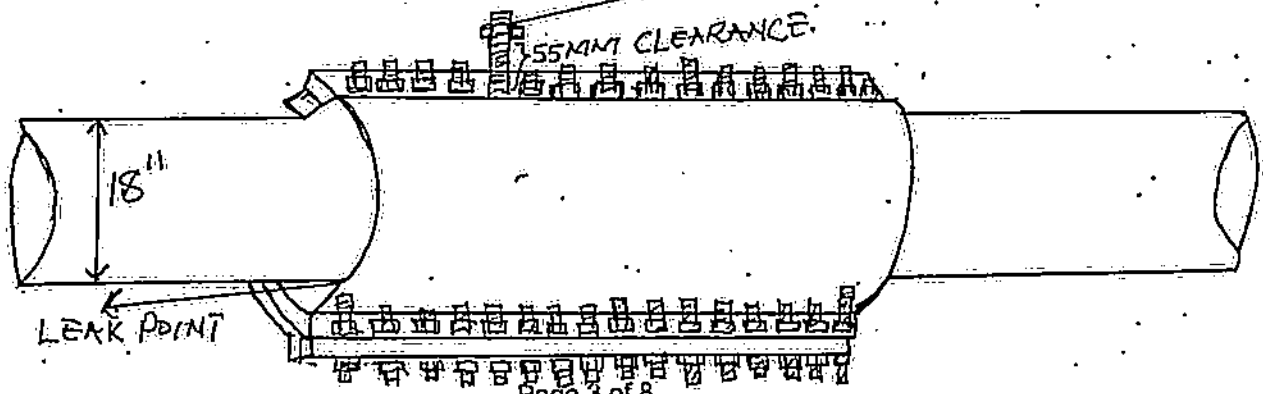
Additional observations around the spill point: JIT OBSERVED THE FIFTH BOLT/NUT WAS TAMPERED WITH BY UNKNOWN PERSON(S).

SECTION OF 18" ASSA - RUMUEKPE TRUNKLINE WITH 18x54" CLAMP AT OMUDIDGA SHOWING TAMPERED FIFTH(S) BOLT/NUT BY UNKNOWN PERSON(S). CLEARANCE BETWEEN THE NUT AND CLAMP BASE IS 55MM. TAMPERED FIFTH(S) BOLT/NUT.
