JOINT INVESTIGATION REPORT

INCIDENT NO: 2098167 JIV report S/N: 1091

1. Spill incident Number: 2098167 2. Type of incident* OIL SPILL
3. Name of Location 24th NKPOKU - BOMU (JNP) PIPELINE
4. Name of nearest community EGBALOR 5. State: RIVERS 6. LGA ELEME
7. Type of Production facility/Installation OIL PIPELINE
8. Asset owner/District THE SHELL PETROLEUM DEVELOPMENT COMPANY / PIPELINE

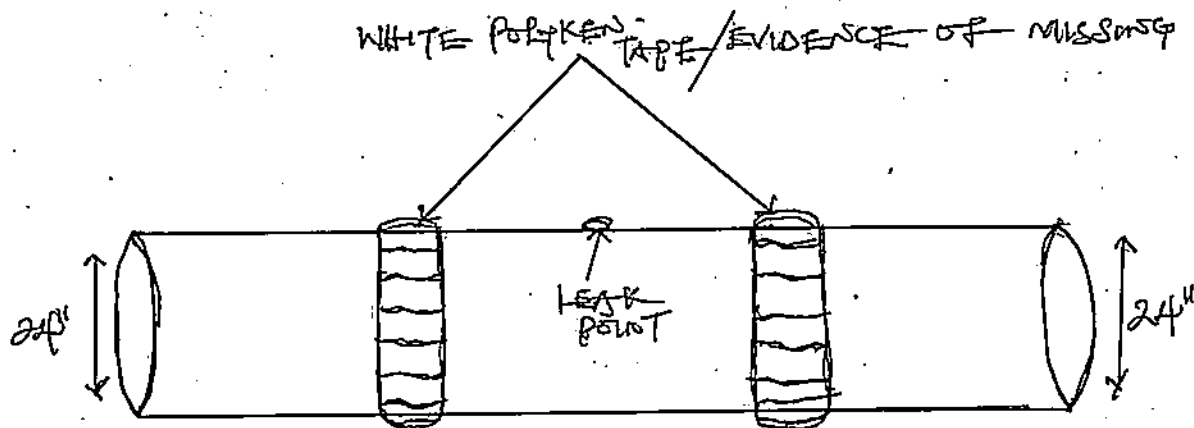
Additional observations around the spill point: THE JOINT INVESTIGATION TEAM OBSERVED EVIDENCE OF MISSING CLAMP AND DRILLED HOLE AT 12 O'CLOCK POSITION FROM PREVIOUS INCIDENT.

| <input checked="" type="checkbox"/> Drilled hole | <input type="checkbox"/> Hack saw cut | <input type="checkbox"/> Tear (_____) |
| <input type="checkbox"/> Corrosion | <input checked="" type="checkbox"/> Others(specify) <u>MISSING CLAMP</u> | |

SECTION OF 24" NKPOKU - BOMU PIPELINE AT EQUATOR SHOWING POSITIONS OF THE MISSING CLAMP AND DRILLED HOLE AT 12 O'CLOCK POSITION (LEAK POINT)
