INCIDENT NO: 2103940 JIV report S/N: 0957 (Note: As practicable as possible the JIT report is to be signed in the field by all the participating parties) A. GENERAL INFORMATION: I. Spill incident Number: 2103940 2. Type of incident\* Of SPILL 3. Name of Location 20" KOLO CREEK - RUMUEUPE (TRUNKLINE) PIPELINE. (KM9)5. Slato: RIVERS 6. LOA ABUA ODUAL 4. Name of nearest community OBKU 7. Type of Production facility/Installation Otl PIPELINE 8. Asset owner/District THE SHELL PETROLEUM DEVELOPMENT COMPANY OF NIGERIA. LIMITED ( PIPECINE B. INCIDENT INFORMATION: 9. Details of incident a. Date of incident: 21<sup>ST</sup> June, 2318 b. Start date/time of investigation: 374 JULY, 2018 c. Investigation End date: 4TH JULY, 2018 Actual investigation duration, days: JK10- DATSd. Description of spill point environment Recently excavated area ☐Firm soil Loose soil Swamov Under water ☐Exposed pipe surface ☐Well Platform (on Water) □Drill Rig Additional observations around the spill point: THE JOINT INVESTIGATION TEAM OBSERVED THE LEAK POINT OTHTSIDE SPDC RIGHT OF WAY ON A 2" PIPE CONNECTED TO THE THEFT POINT ILLEGALLY INSTALLED ON THE 20" KOLO CREEK -RUMUEKPE PIPELINE AT BOAY (KM9). c. Description

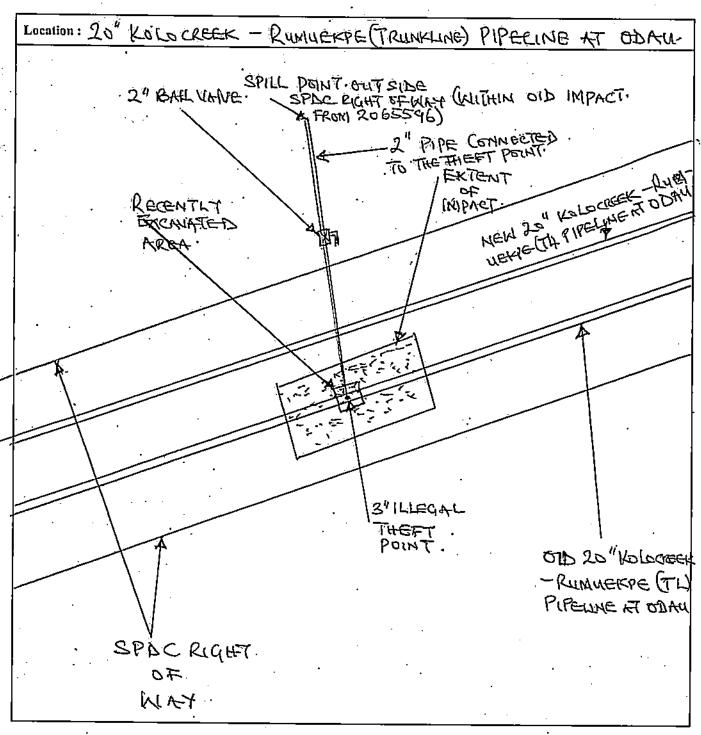
f. Appendix 1: Overview sketch of the site

19. Others (Specify) i.e. Animal Traps							
S/N Others Description : Quantity/Size Comments							
NONE WITHIN AR A OF IMPACT							
E. GRAPHIC DESCRIPTION OF LEAK POINT (While detail report of the leak point should be contained in the leak report, overview sketch of the site should be added as an appendix l)							
SECTIONAL VIEW OF 20" KO LO CREEK-RUMUEKPE (TRUNKLINE) PIPELINE							
AT ODAY SHOWING: LEAK DUE TO 3" BALL VALUE THEFT FITTING							
INSTALLED AT 120' CLOCK POSTION BY UNKNOWN PERSONG)							
3" REDUKE TO 2" SPILL							
3" PIPE POINT OU DIRE SPILL							
NON LEAKING TO THEFT FITTING EXTENTION							
3" BATI VALUE INTO THE FOREST							
INSTALLED AT 3" NIPPLE							
2 (							
Page 3 of 8
