JOINT INVESTIGATION REPORT

INCIDENT NO: 2037197 JIV report S/N: 10??

1. Spill incident Number: 2037197 2. Type of incident* OIL SPILL
3. Name of Location 20" RUMUEKPE - NKPOKU PIPELINE
4. Name of nearest community MBODO-ALUU 5. State: RIVERS 6. LGA IKWERRE
7. Type of Production facility/Installation OIL PIPELINE
8. Asset owner/District THE SHELL PETROLEUM DEVELOPMENT COMPANY OF NIGERIA LIMITED / PIPELINE

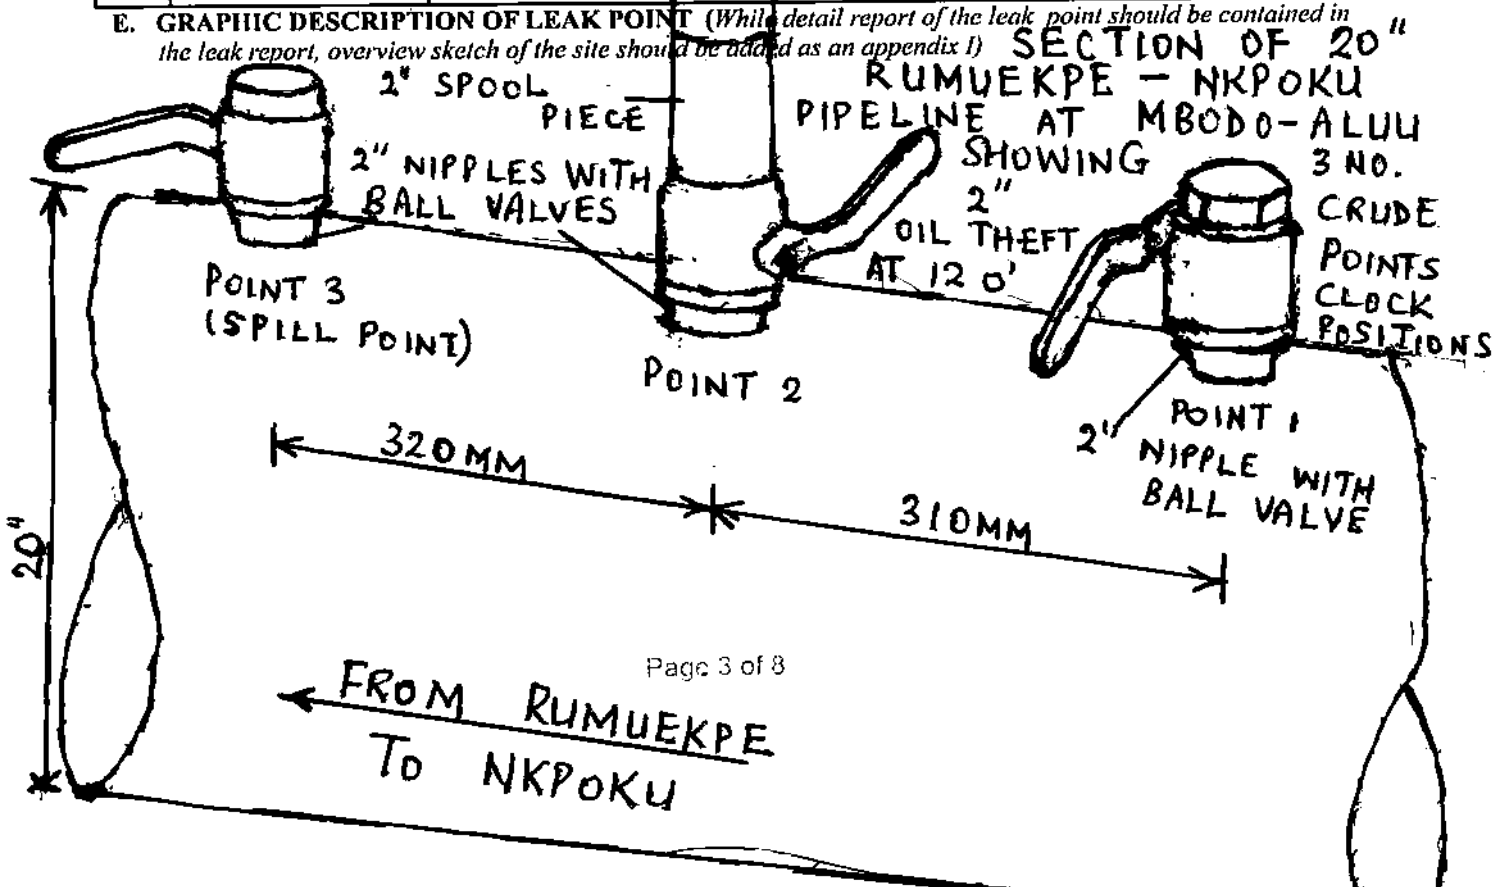
E. GRAPHIC DESCRIPTION OF LEAK POINT (While detail report of the leak point should be contained in the leak report, overview sketch of the site should be added as an appendix I)

Additional observations around the spill point: ON ARRIVAL AT SITE, THE JOINT INVESTIGATION TEAM OBSERVED AN ILLEGAL HOSE ATTACHED TO ONE OF THE PARTIALLY EXPOSED CRUDE OIL THEFT POINTS. SOME SAND BAGS LEFT BY UNKNOWN PERSON(S) WERE ALSO OBSERVED WITHIN THE VICINITY OF AN OBSERVED DITCH AROUND SPILL POINT

| <input checked="" type="checkbox"/> Crude oil theft (illegal bunkering) point, | <input type="checkbox"/> Saver-pit over flow | <input type="checkbox"/> Third party tampering with Clamp |

RECOVERY OF FREE-PHASE OIL WAS DONE AND REPAIR WAS CARRIED OUT ON THE AFFECTED PIPELINE SECTION BY CLAMPING.
