JOINT INVESTIGATION REPORT

INCIDENT NO: 2045702 JIV report S/N: 1043

1. Spill incident Number: 2045702 2. Type of incident* OIL SPILL
3. Name of Location UKPELEDE MANIFOLD
4. Name of nearest community UKPELEDE 5. State: RIVERS 6. LGA AKHADA WEST
7. Type of Production facility/Installation MANIFOLD
8. Asset owner/District THE SHELL PETROLEUM DEVELOPMENT COMPANY OF NIGERIA LIMITED/ PIPELINE

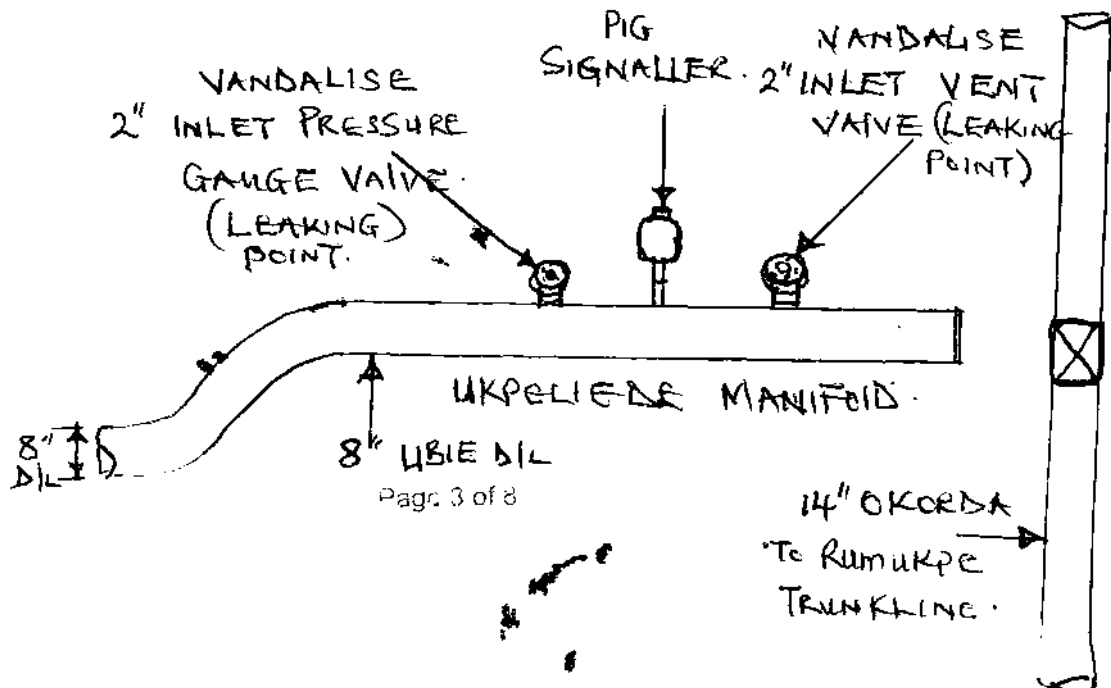
Additional observations around the spill point: ON THE 8" UBIE DELIVERY LINE A 2" INLET PRESSURE GAUGE VALVE AND 2" INLET VENT WERE OBSERVED VANDALISED BY UNKNOWN PERSON(S)

| <input checked="" type="checkbox"/> Third party tampering with valve setting | <input type="checkbox"/> Bulging Outward | <input type="checkbox"/> Third party tampering with flange, |

SECTIONAL VIEW OF UKPELEDE MANIFOLD AT UKPELEDE
SHOWING TWO (2) NO OF 2" VANDALISE VALVES AT THE MANIFOLD

RECOVERY WORK IS ONGOING, WHILE REPAIR WORK IS PLAN TO COMMENCE TOMORROW (THE 7TH APRIL 2018).
