JOINT INVESTIGATION REPORT

INCIDENT NO: 2052271 JIV report S/N: 1047

1. Spill incident Number: 2052271 2. Type of incident*: OIL SPILL
3. Name of Location 14" OKORDIA - RUMUEKPE PIPELINE
4. Name of nearest community IKARAMA 5. State: BAYELSA 6. LGA: YENAGOA
7. Type of Production facility/Installation OIL PIPELINE
8. Asset owner/District SPDC / PIPELINE

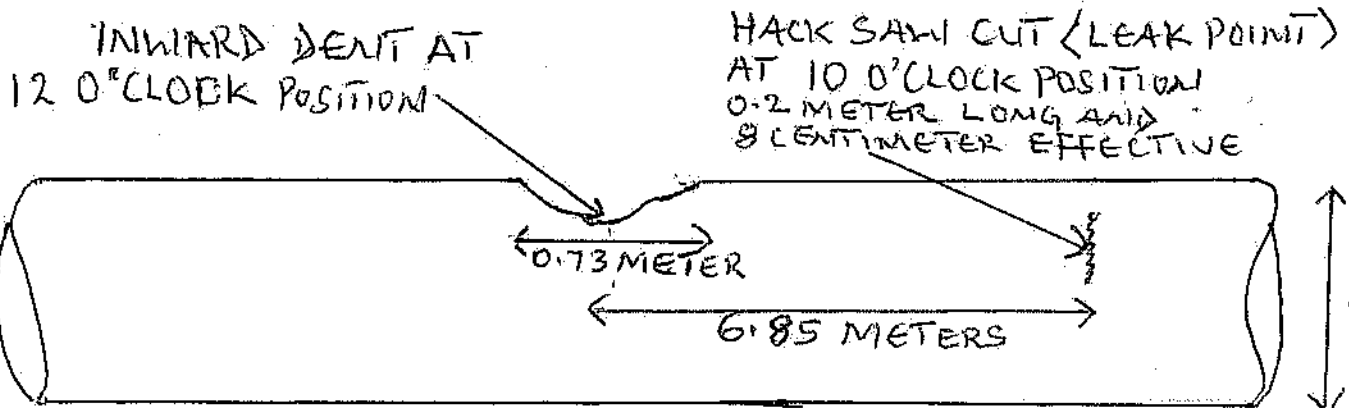
Additional observations around the spill point: JOINT INVESTIGATION TEAM OBSERVED INWARD DENT DUE TO SUSPECTED EXPLOSIVE MATERIAL AND HACK SAW CUT DURING THE INVESTIGATION (6.85 METERS APART).

SECTION OF 14" OKORDIA - RUMUEKPE PIPELINE AT IKARAMA SHOWING POSITIONS OF INWARD BENT AND HACK SAW CUT.

RECOVERY ACTIVITIES ONGOING. REPAIR WORK ON AFFECTED SECTION OF THE PIPELINE ONGOING.
