JOINT INVESTIGATION REPORT

INCIDENT NO: 2078117 JIV report S/N: 1056

1. Spill incident Number: 2078117 2. Type of incident* OIL SPILL
3. Name of Location AGBADA WELL 47L FLOWLINE
4. Name of nearest community OMUEKE (IGWURUTA) 5. State: RIVERS 6. LGA IKWERRE
7. Type of Production facility/Installation OIL FLOWLINE
8. Asset owner/District THE SHELL PETROLEUM DEVELOPMENT COMPANY OF NIGERIA LIMITED/ LAND EAST HUB

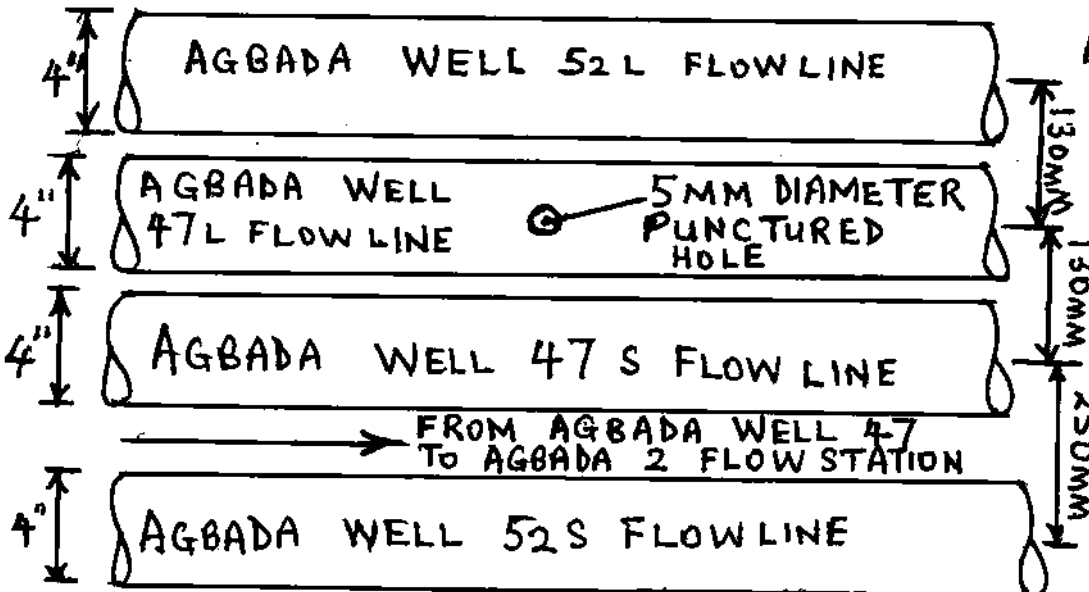
Additional observations around the spill point: THE SPILL POINT WAS OBSERVED APPROXIMATELY 5 METRES FROM THE TARRED ACCESS ROAD. UPON EXPOSURE BY EXCAVATION, THREE (3) OTHER FLOWLINES WERE OBSERVED CLOSE TO THE WELL 47L FLOWLINE, NAMELY: AGBADA WELLS 52S, 47S AND 52L FLOWLINES.

| <input type="checkbox"/> Corrosion | <input checked="" type="checkbox"/> Others(specify) <u>PUNCTURED HOLE</u> | |

SECTION OF AGBADA WELL 47L FLOWLINE (WITHIN FLOW LINES CLUSTER) AT OMUEKE (IGWURUTA) SHOWING PUNCTURED HOLE (LEAK POINT) AT 12 O' CLOCK POSITION.
