JOINT INVESTIGATION REPORT

INCIDENT NO: 2079259 JIV report S/N: 1129

1. Spill incident Number: 2079259 2. Type of incident* OIL SPILL
3. Name of Location 20" OTUMARA - ESCRAVOS PIPELINE
4. Name of nearest community UGBODEGUNGUN State: DELTA G. LGA WARRI SOUTH-WEST
7. Type of Production facility/Installation OIL PIPELINE
8. Asset owner/District THE SHELL PETROLEUM DEVELOPMENT COMPANY OF NIGERIA LIMITED / PIPELINES

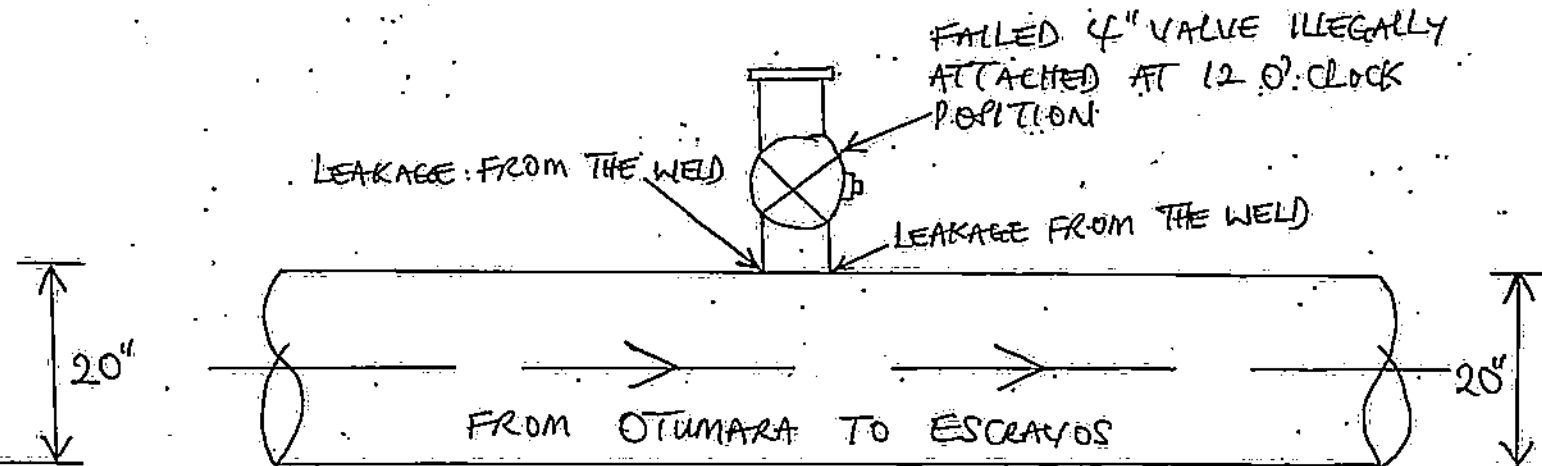
Additional observations around the spill point: UPON EXPOSURE OF THE LEAK POINT, THE JOINT INVESTIGATION TEAM OBSERVED A FAILED 4" VALVE (LEAKING FROM THE WELD) ILLEGALLY ATTACHED TO THE 20" OTUMARA-ESCAVOS PIPELINE AT 1 O'CLOCK POSITION

| <input checked="" type="checkbox"/> Failed Weld-on illegal hot tap valve | <input type="checkbox"/> Failed Clamp, | <input type="checkbox"/> Missing Pipeline/Flowline |

SECTION OF 20" OTUMARA - ESCRAYOS PIPELINE AT UGBOGUNGUN SHOWING POSITION OF FAILED 4" VALVE AT 12 O' CLOCK.
