# JOINT INVESTIGATION REPORT

INCIDENT NO: 2084608 JIV report S/N: 1049

1. Spill incident Number: 2084608 2. Type of incident\* OIL SPILL  
3. Name of Location 12" ADIBAWA - OKORDIA PIPELINE  
4. Name of nearest community IKARAMA 5. State: BAYELSA 6. LGA YENAGDA  
7. Type of Production facility/Installation OIL PIPELINE  
8. Asset owner/District THE SHELL PETROLEUM DEVELOPMENT COMPANY OF NIGERIA LTD (SPDC)/PIPELINE

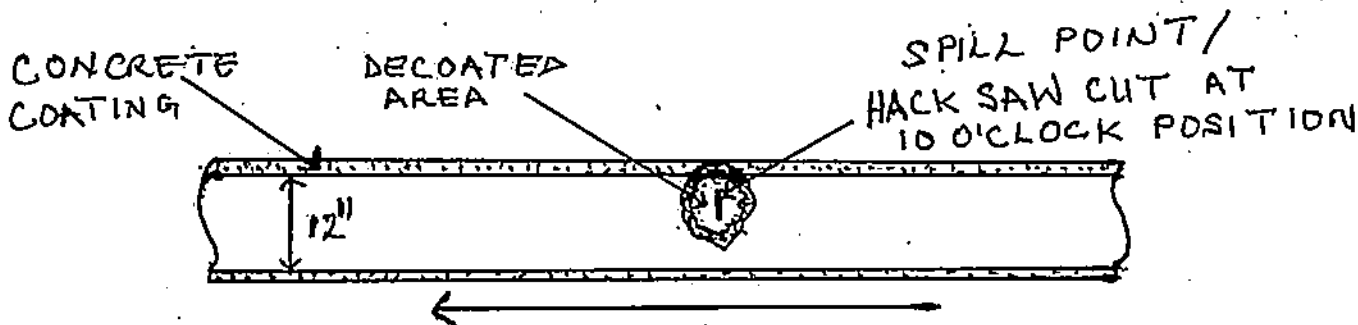
Additional observations around the spill point: THE JOINT INVESTIGATION TEAM OBSERVED A HACK SAW CUT AT 10'O'CLOCK POSITION.

A SECTION 12" ADIBAWA — DKORDIA PIPELINE AT IKARAMA SHOWING HACK SAW CUT IN A DECOATED AREA, AT 10 O'CLOCK POSITION, BY UNKNOWN PERSONS.
