JOINT INVESTIGATION REPORT

INCIDENT NO: 2070768 JIV report S/N: 1115

1. Spill incident Number: 2070768 2. Type of incident* OIL SPILL
3. Name of Location 20" OTUMARA - ESCRAVOS PIPELINE
4. Name of nearest community UGBOGUNGUN 5. State: DELTA 6. LGA WARRI SOUTH - WEST
7. Type of Production facility/Installation OIL PIPELINE
8. Asset owner/District THE SHELL PETROLEUM DEVELOPMENT COMPANY OF NIGERIA
B. INCIDENT INFORMATION: LIMITED / PIPELINES

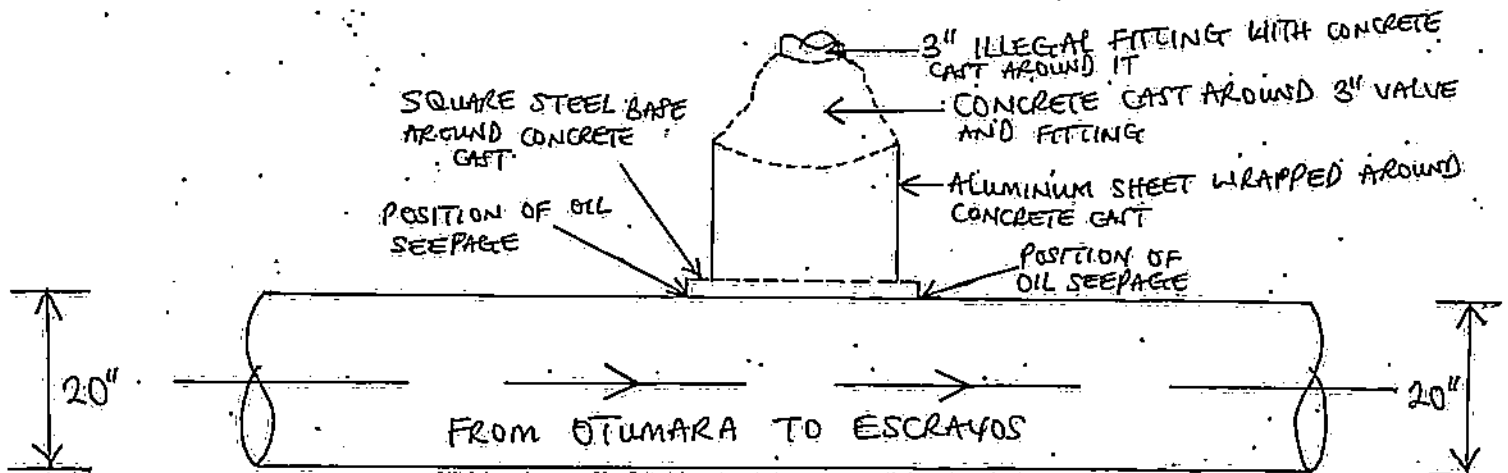
Additional observations around the spill point: DURING INSPECTION, THE JOINT INVESTIGATION TEAM OBSERVED CRUDE OIL DRIPPING FROM THE BASE OF THE CONCRETE CAST AROUND THE 3" ILLEGAL CONNECTION, ON THE 20" OTUMARA - ESCRAVOS PIPELINE AT 12 O' CLOCK POSITION. JIV WAS INITIALLY CONDUCTED ON SAME POINT WITH FID: 1996050 ON 26TH APRIL, 2018 AND WAS CLOSED OUT AS NON-LEAKING.

| <input checked="" type="checkbox"/> Failed Weld-on illegal hot-tap valve | <input type="checkbox"/> Failed-Clamp, | <input type="checkbox"/> Missing Pipeline/Flowline |

E. GRAPHIC DESCRIPTION OF LEAK POINT (While detail report of the leak point should be contained in the leak report, overview sketch of the site should be added as an appendix I)
SECTION OF 20" OTUMARA- ESCRAYOS PIPELINE AT UGBOEGUNGUN
SHOWING POSITION OF FAILED 3" VALVE WITH CONCRETE CASTING AROUND IT
