JOINT INVESTIGATION REPORT

INCIDENT NO: 2078520 JIV report S/N: 1130

1. Spill incident Number: 2078520 2. Type of incident* OIL SPILL
 3. Name of Location: 24" TRANS - ESCRAVOS PIPELINE
 4. Name of nearest community OBOTOBO 5. State: DELTA 6. LGA BURUTU
 7. Type of Production facility/Installation OIL PIPELINE
 8. Asset owner/District THE SHELL PETROLEUM DEVELOPMENT COMPANY OF NIGERIA LIMITED / PIPELINES

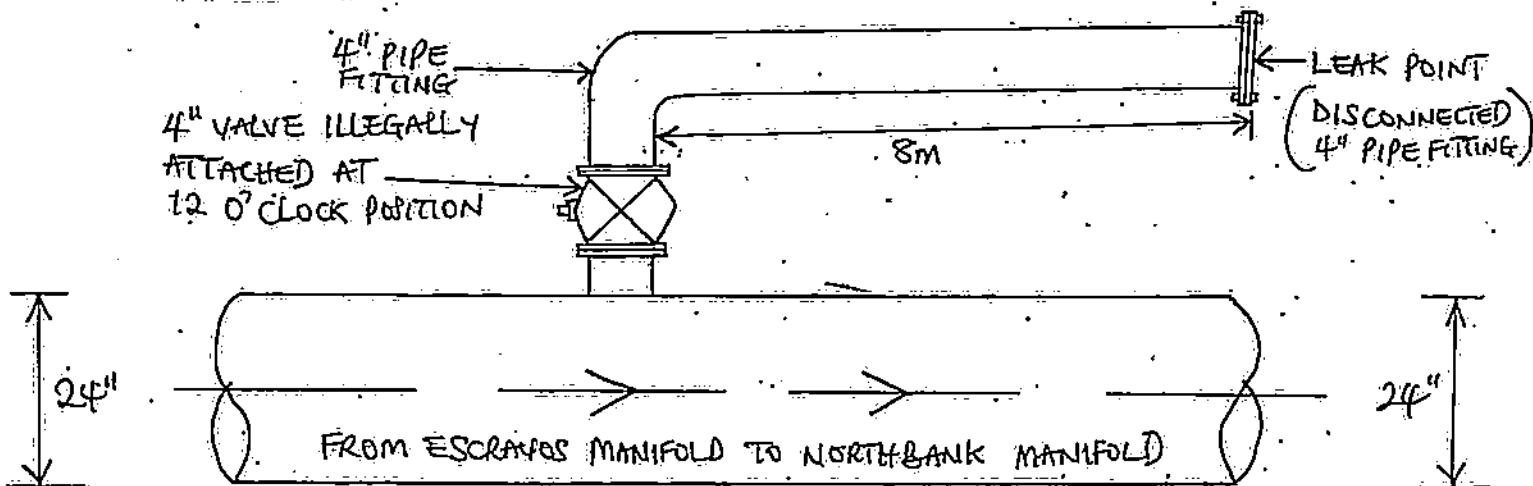
Additional observations around the spill point: UPON EXPOSURE BY EXCAVATION, AN ILLEGAL 4" VALVE WITH PIPE FITTING WAS SEEN ON THE 24" TRANS-ESCRAVOS PIPELINE AT 12 O'CLOCK POSITION. THE 4" ILLEGAL PIPE FITTING WAS DISCONNECTED ABOUT 8M FROM THE POINT OF ATTACHMENT TO THE 24" OIL PIPELINE. THE LEAK WAS OBSERVED TO HAVE STOPPED AS AT THE TIME OF THIS INVESTIGATION

| <input checked="" type="checkbox"/> Failed Weld-on illegal hot tap valve | <input type="checkbox"/> Failed Clamp, | <input type="checkbox"/> Missing Pipeline/Flowline |

SECTION OF 24" TRANS-ESCRAVOS PIPELINE AT 0807.080 AXIS
SHOWING POSITION OF 4" VALVE WITH PIPE FITTING, ILLEGALLY ATTACHED AT
12 O' CLOCK
