JOINT INVESTIGATION REPORT

INCIDENT NO: 2072151 JIV report S/N 1076

1. Spill incident Number: 2072151 2. Type of incident* OIL SPILL
3. Name of Location 24" TRANS - RAMOS PIPELINE
4. Name of nearest community ODIMODI 5. State: DELTA 6. LGA BURUTU
7. Type of Production facility/Installation: OIL PIPELINE
8. Asset owner/District THE SHELL PETROLEUM DEVELOPMENT COMPANY OF NIGERIA LIMITED / PIPELINE

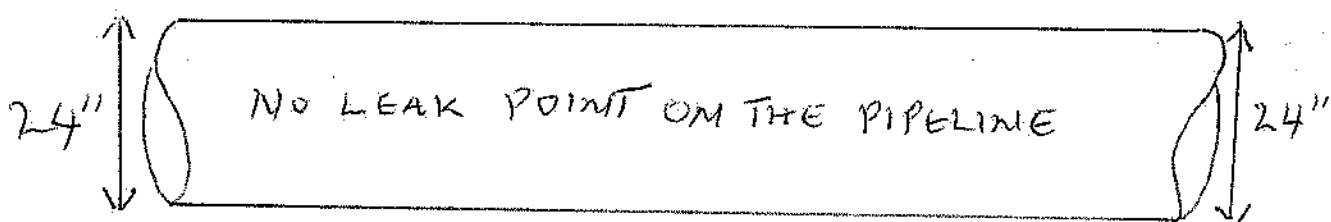
NO LEAK POINT WAS OBSERVED ON THE PIPELINE AFTER THE EXCAVATION.

SECTION OF 24" TRANS-RAMOS PIPELINE AT ODIMODI
SHOWING NO LEAK POINT ON THE PIPELINE
