# JOINT INVESTIGATION REPORT

INCIDENT NO: 2081062 JIV report S/N: 1140

1. Spill incident Number: 2081062 2. Type of incident\* OIL SPILL  
3. Name of Location 24" TRANS - RAMOS PIPELINE  
4. Name of nearest community AGHORO 2 5. State: BAYELSA 6. LGA EKEREMOR  
7. Type of Production facility/Installation OIL PIPELINE  
8. Asset owner/District THE SHELL PETROLEUM DEVELOPMENT COMPANY  
OF NIGERIA LIMITED / PIPELINE

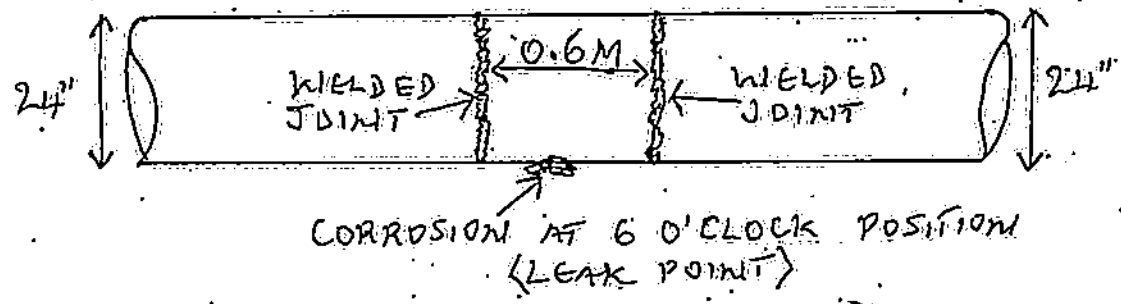
Additional observations around the spill point: AFTER THE AFFECTED PIPE LINE WAS LIFTED AND UNWRAPPED, A CORRODED LEAK POINT WAS OBSERVED BETWEEN TWO WELDED JOINTS AT 6 O'CLOCK POSITION.

| <input checked="" type="checkbox"/> Corrosion | <input type="checkbox"/> Others(specify) _____ | |

SECTION OF 24" TRANS - RAMOS PIPELINE AT ALVARO 2 SHOWING CORROSION AT 6 O'CLOCK POSITION
