# JOINT INVESTIGATION REPORT

INCIDENT NO: 2074658 JIV report S/N: 0160

1. Spill incident Number: 2074658 2. Type of incident\* OIL SPILL  
3. Name of Location 28" BOMU - BUNNY TRANS NIGER PIPELINE  
4. Name of nearest community KPOR / K-DERE 5. State: RIVERS 6. LGA: GIKAMA  
7. Type of Production facility/Installation OIL PIPELINE  
8. Asset owner/District THE SHELL PETROLEUM DEVELOPMENT COMPANY OF NIGERIA LIMITED / PIPELINE

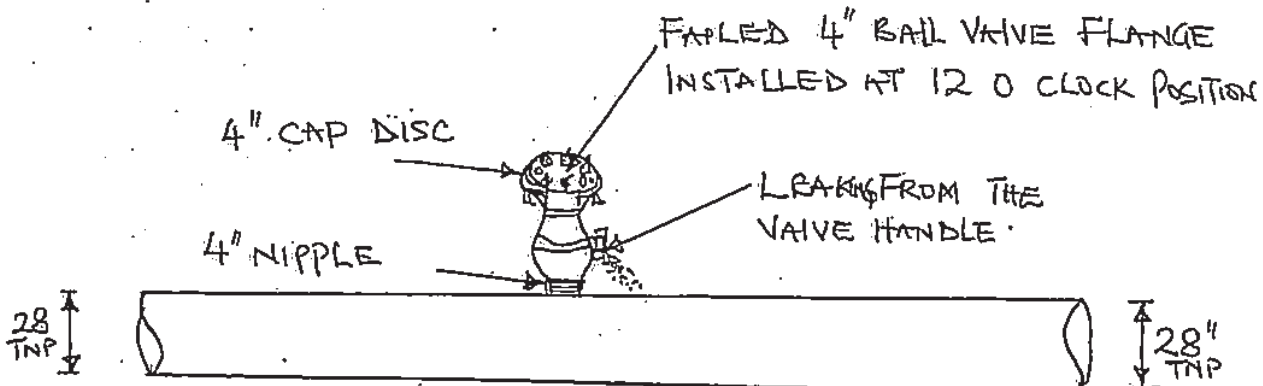
| <input checked="" type="checkbox"/> Failed Weld-on illegal hot tap valve | <input type="checkbox"/> Failed Clamp | <input type="checkbox"/> Missing Pipeline/Flowline |
| <input checked="" type="checkbox"/> Crude oil theft (illegal bunkering) point | <input type="checkbox"/> Saver-pit over flow | <input type="checkbox"/> Third party tampering with Clamp |

SECTIONAL VIEW OF 28" BOMU-BONNY TRANS NIGER PIPELINE  
SHOWING: FAILED 4" WELD-ON ILLEGAL HOT TAP VALVE

RECOVERY WORK AND REPAIR WORK BY CLAMPING ON -  
GOING
