# JOINT INVESTIGATION REPORT

INCIDENT NO: 2201331 JIV report S/N: 0172

1. Spill incident Number: 2201331 2. Type of incident: OIL SPILL (CRUDE THEFT POINT)  
3. Name of Location: 20" KOLA CREEK - RUMUEKPE PIPELINE  
4. Name of nearest community: OKOMA-1 5. State: RIVERS 6. LGA: AHOADA EAST  
7. Type of Production facility/Installation: OIL PIPELINE  
8. Asset owner/District: THE SHELL PETROLEUM DEVELOPMENT COMPANY OF NIGERIA LIMITED PIPELINE.

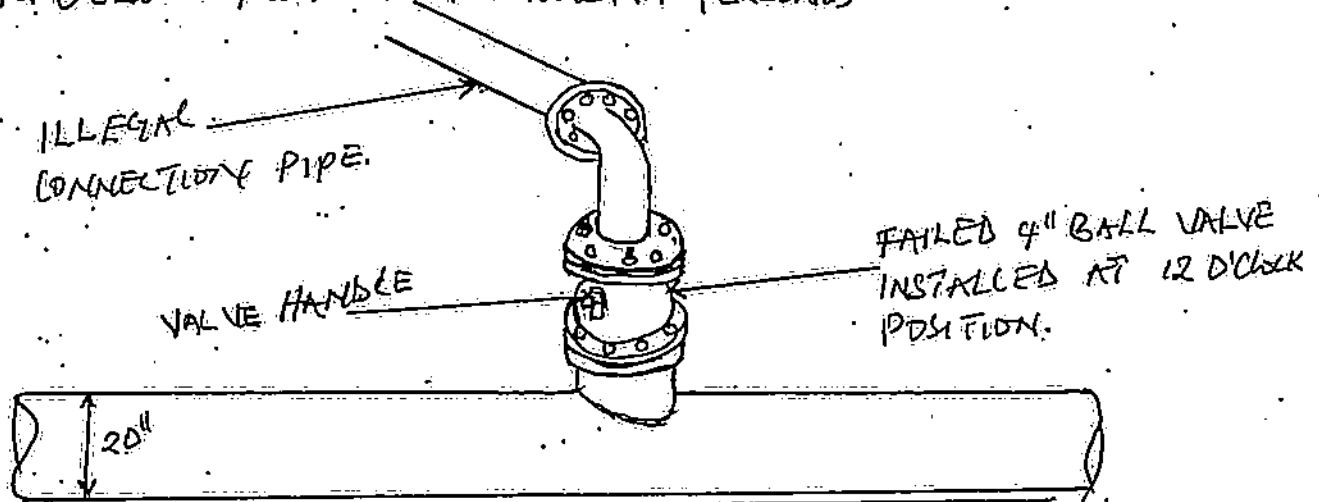
Additional observations around the spill point: THE JOINT INVESTIGATION TEAM OBSERVED A FAILED 4" BALL VALVE INSTALLED AT 12 O'CLOCK POSITION.

| <input checked="" type="checkbox"/> Failed Weld-on illegal hot tap valve | <input type="checkbox"/> Failed Clamp | <input type="checkbox"/> Missing Pipeline/Flowline |

**E. GRAPHIC DESCRIPTION OF LEAK POINT** (while detailed report of the leak point should be contained in the leak report, overview sketch of the site should be added as an appendix 1) **A SECTION OF 20" KOLA CREEK-RUMUEKPE PIPELINE AT OKDMA-1 SHOWING A 4" BALL VALVE INSTALLED AT 12 O'CLOCK POSITION BY UNKNOWN PERSON(S).**

REPAIR BY BLIND FLANGE DRAGGING.
