Overview: Part of spill impact on Imo River Well 36 Gas Lift Line Igiriukwu-Owaza. Picture was taken during Joint Investigation of 21st November 2018..

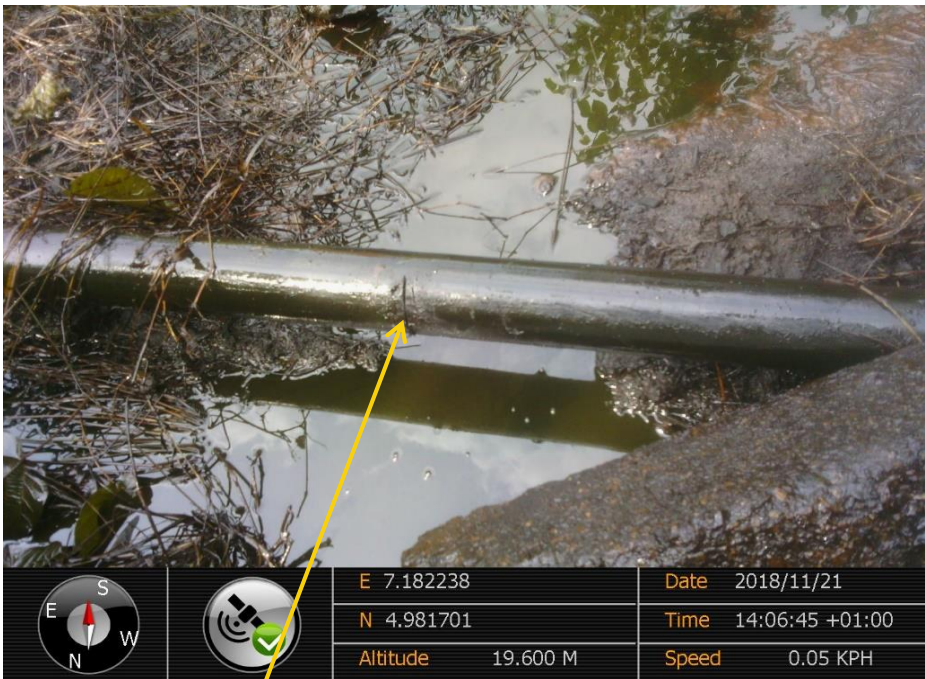
Close-up: Leaking Hacksaw Cut on Imo River Well 36 Gas Lift Line Igiriukwu-Owaza. Picture was taken during Joint Investigation of 21st November 2018.
