JOINT INVESTIGATION REPORT

INCIDENT NO: 2208279 JIV report S/N: 0097

1. Spill incident Number: 2208279 2. Type of incident* OIL SPILL
3. Name of Location 24" NKPOKU - BOMU PIPELINE (TNP)
4. Name of nearest community BARA-ALUE 5. State: RIVERS 6. LGA TAI
7. Type of Production facility/Installation OIL PIPELINE
8. Asset owner/District THE SHELL PETROLEUM DEVELOPMENT COMPANY OF NIGERIA LIMITED / PIPELINE

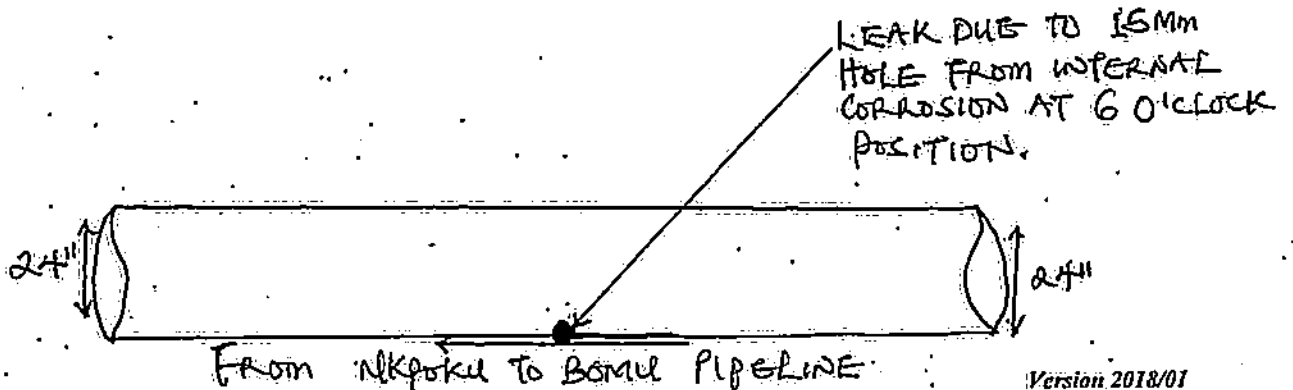
| <input checked="" type="checkbox"/> Corrosion | <input type="checkbox"/> Others(specify) _____ | |

A SECTION OF 24" NIKPOKU-BOMU PIPELINE AT BARA-BLUE SHOWING 15MM HOLE FROM INTERNAL CORROSION AT SIX (6) O'CLOCK POSITION.

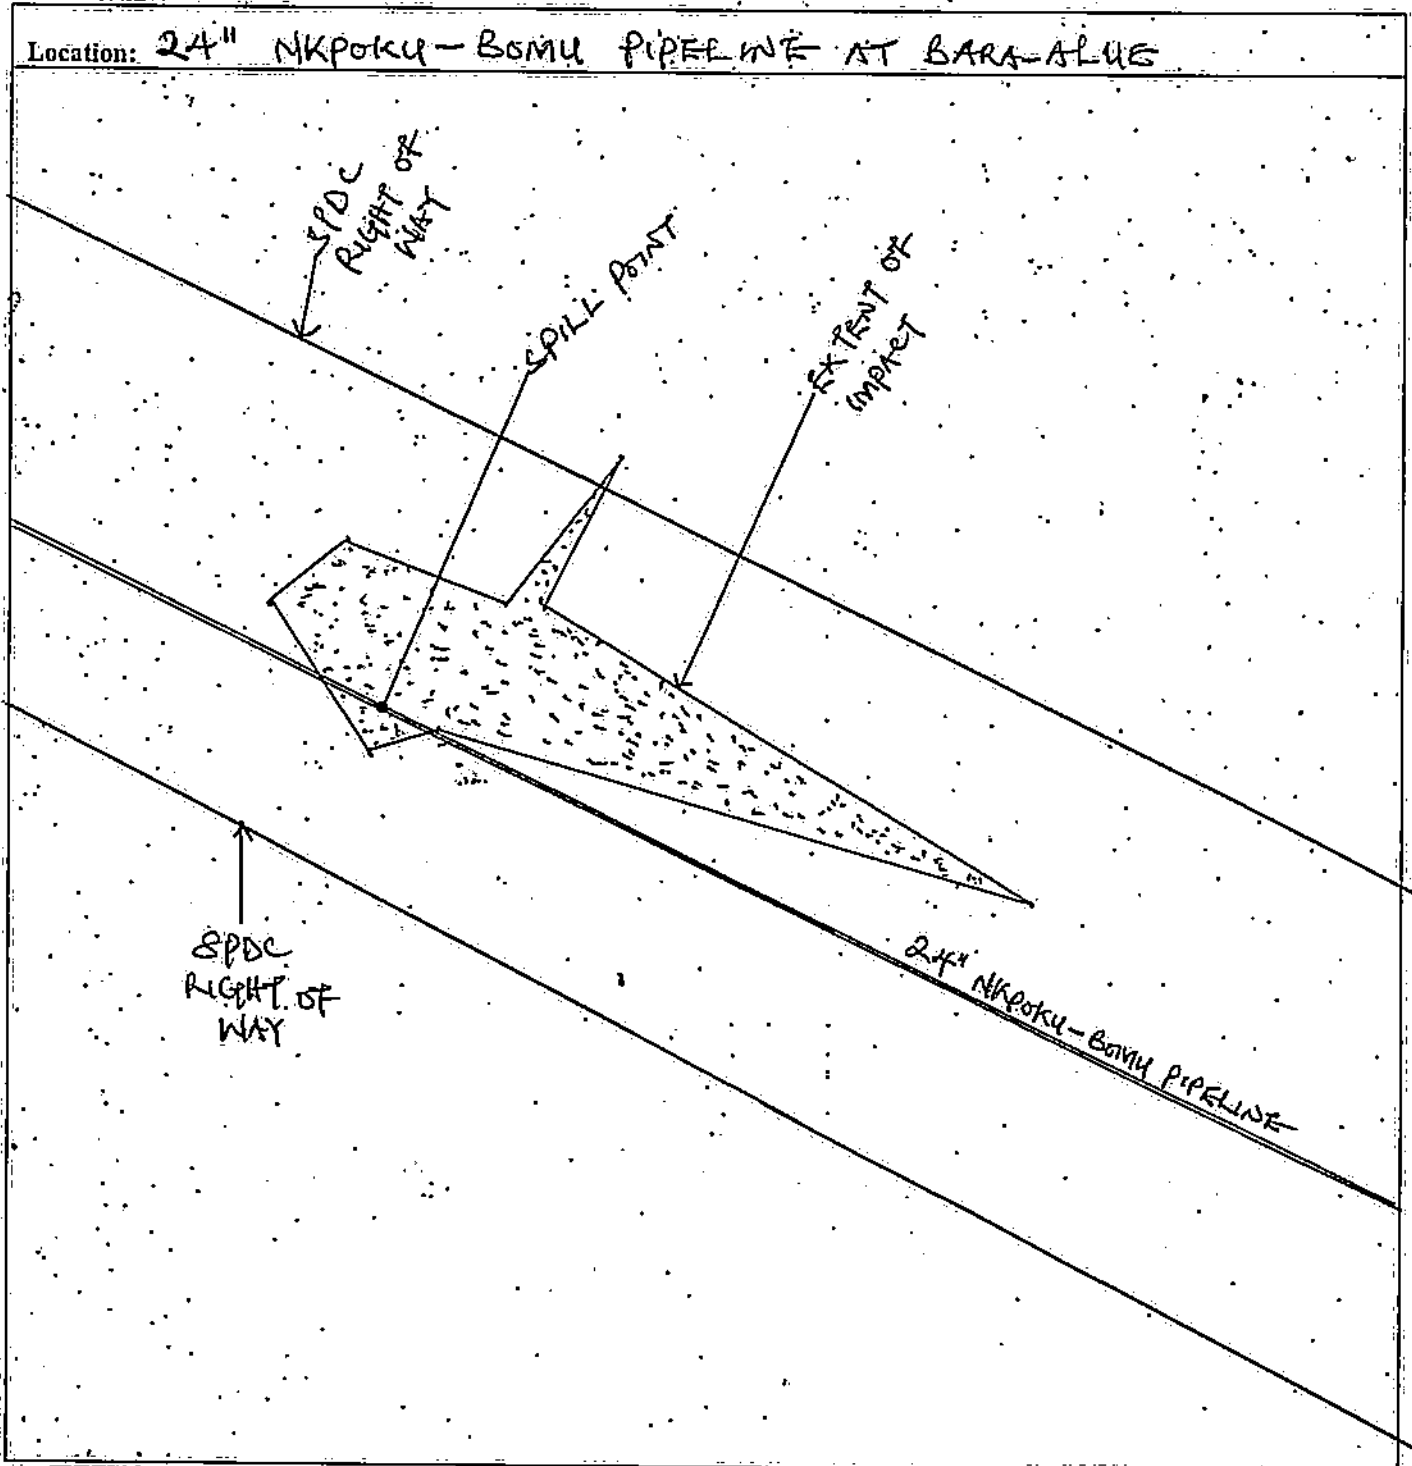
f. Appendix 1: Overview sketch of the site

- Total calculated area of impact 0.032878 Ha.
- Impact within R.O.W YES
- Impact outside R.O.W YES
