JOINT INVESTIGATION REPORT

INCIDENT NO: 2018-2204293 JIV report S/N: 0185

1. Spill incident Number: 2018-2204293 2. Type of incident*: OIL SPILL
3. Name of Location: 4" OBELE-IBAA DELIVERY LINE R.O.W AT IBAA
4. Name of nearest community IBAA 5. State: RIVERS 6. LGA EMOHUA
7. Type of Production facility/Installation OIL PIPELINE

8. Asset owner/District THE SHELL PETROLEUM DEVELOPMENT COMPANY OF NIGERIA LIMITED PIPELINE

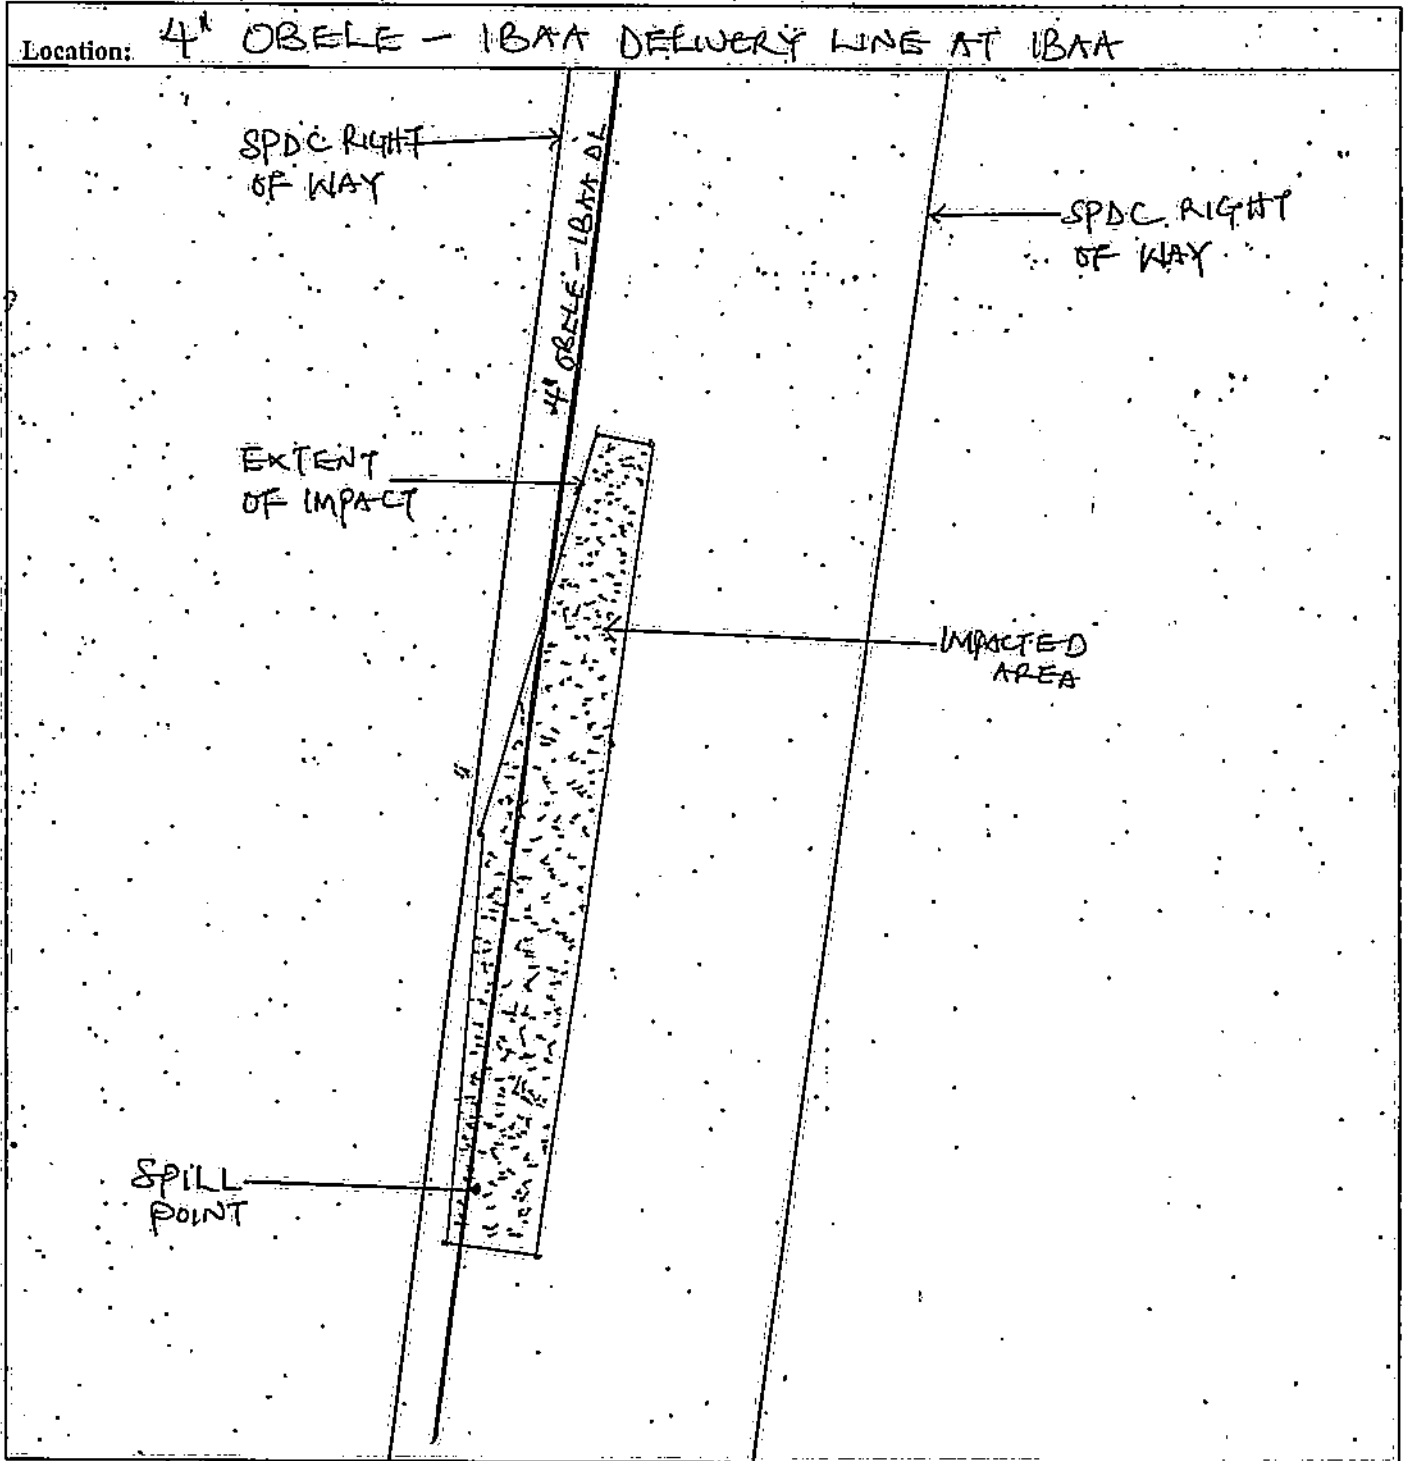
f. Appendix 1: Overview sketch of the site

A SECTION OF 4" OBELE-IBAA DELIVERY LINE, RIGHT OF WAY AT IBAA SHOWING HACK SAW CUT AT 12 O'CLOCK POSITION BY UNKNOWN PERSONS.

90mm HACK SAW CUT FROM 12 O'CLOCK TO 1 O'CLOCK POSITION

REPAIR BY CLAMPING ONGOING
