JOINT INVESTIGATION REPORT

INCIDENT NO: 2209528 JIV report S/N: 0177

1. Spill incident Number: 2209528 2. Type of incident*: OIL SPILL
3. Name of Location 28th NKPOKU - BOMU PIPELINE (TNP)
4. Name of nearest community KPOKOR 5. State: RIVERS 6. LGA TAI
7. Type of Production facility/Installation OIL PIPELINE
8. Asset owner/District THE STEEL PETROLEUM DEVELOPMENT COMPANY OF NIGERIA LIMITED (SPDC) / PIPELINE

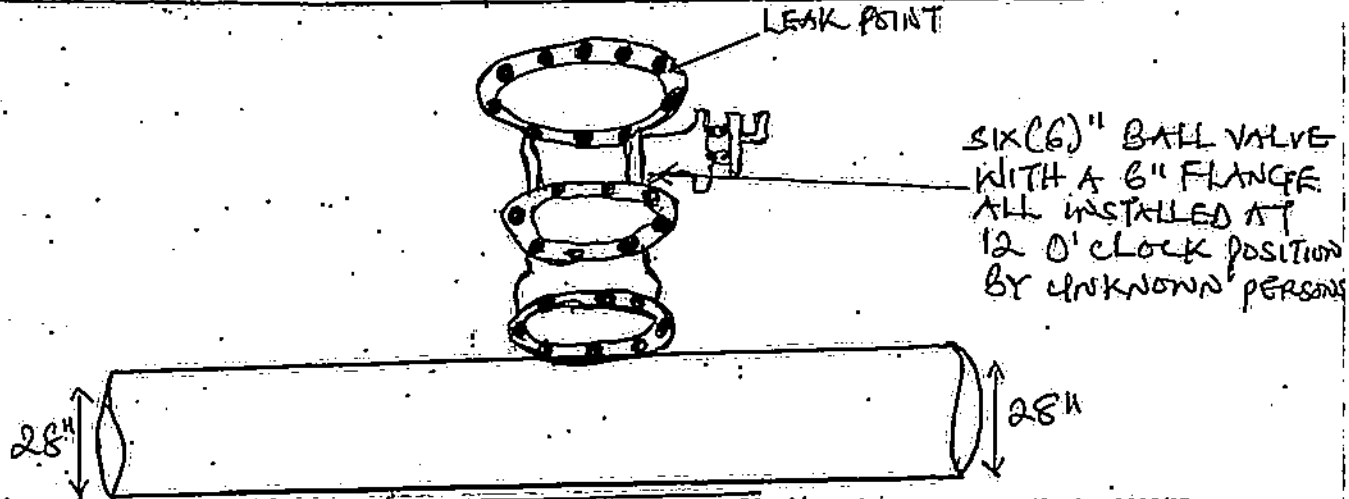
E. GRAPHIC DESCRIPTION OF LEAK POINT (while detailed report of the leak point should be contained in the leak report, overview sketch of the site should be added as an appendix) A SECTION OF 28" NIKOPU-BOMU PIPELINE AT KPOGHOR SHOWING A 6" BALL VALVE WITH A 6" FLANGE INSTALLED AT 12 O'CLOCK POSITION BY UNKNOWN PERSONS.

FROM NIKOPU TO BOMU PIPELINE
